Rehabilitate Eastern Approach

New York State Capitol
Albany, New York

OGS Project S6574

Simpson Gumpertz & Heger

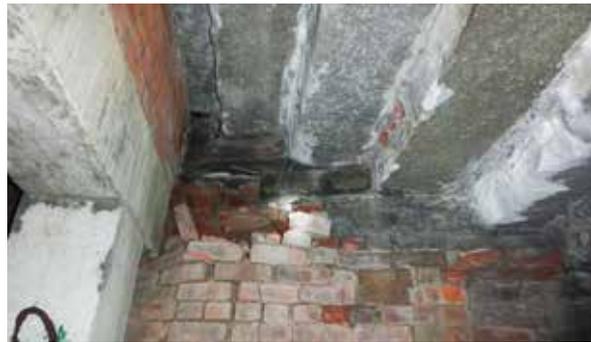
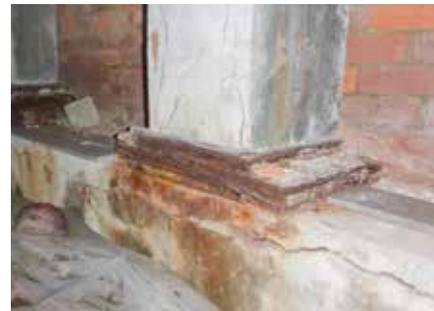
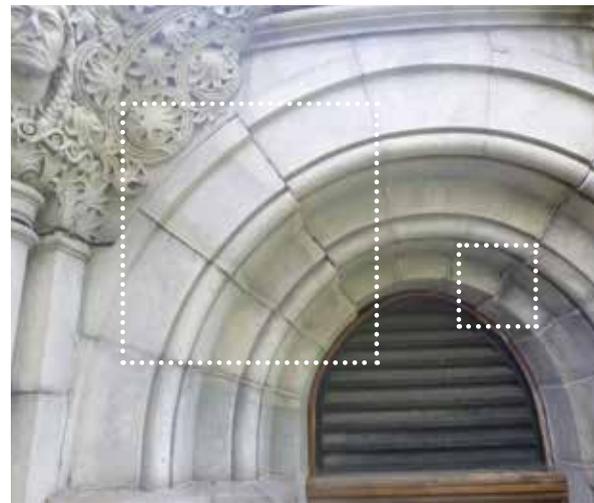
Clockwise from left:
Figure 6a Deteriorated and unstable brick masonry below Flight 3.
Figure 6b Typical corroded steel baseplates and shims below shoring members.
Figure 6c Displaced stones at cornice and arched windows.

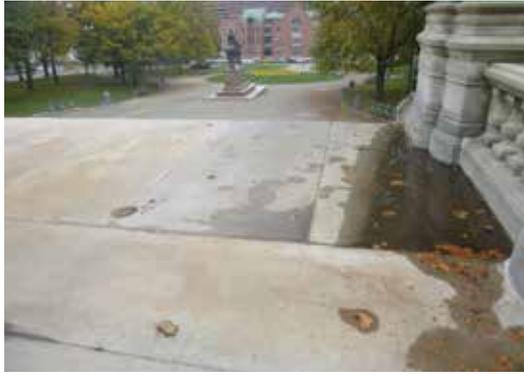
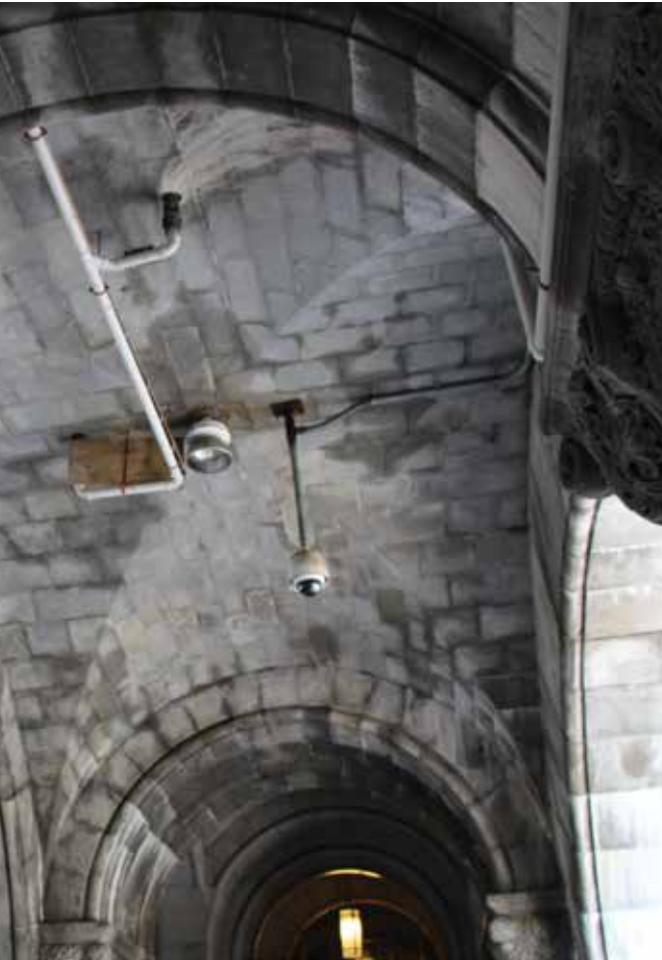
Clockwise from top left:
Figure 22a Water ponding at uneven stones on Landing 2.
Figure 22b Water ponding at Landing 2 rising wall.
Figure 22c Remedial PVC drain piping at underside of Landing 4.

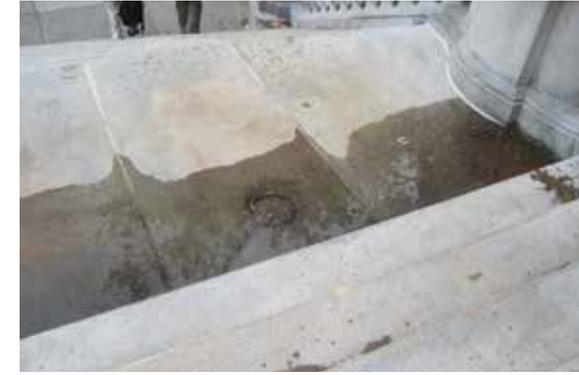
Clockwise from top left:
Figure 23a Water ponding around clogged drain at Landing 1.
Figure 23b Failed storm drainage pipe below Landing 1.
Figure 23c Water test at Landing 2 railing.
Figure 23d Leakage in basement space below water test.

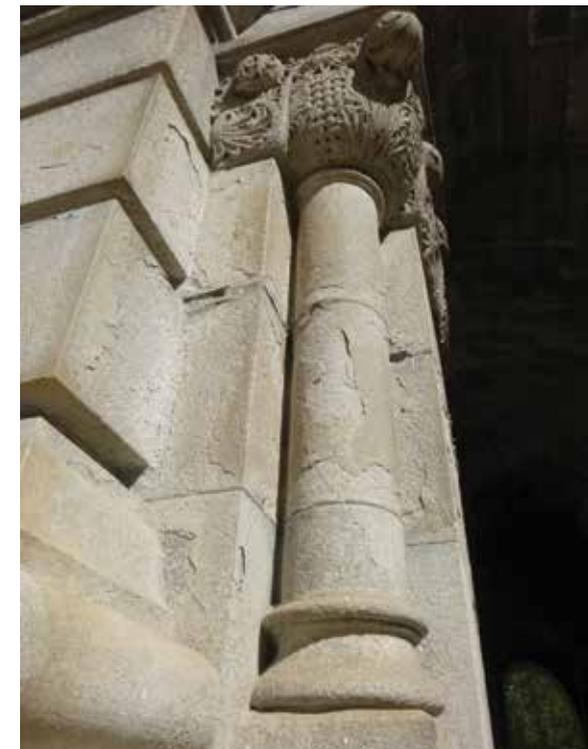
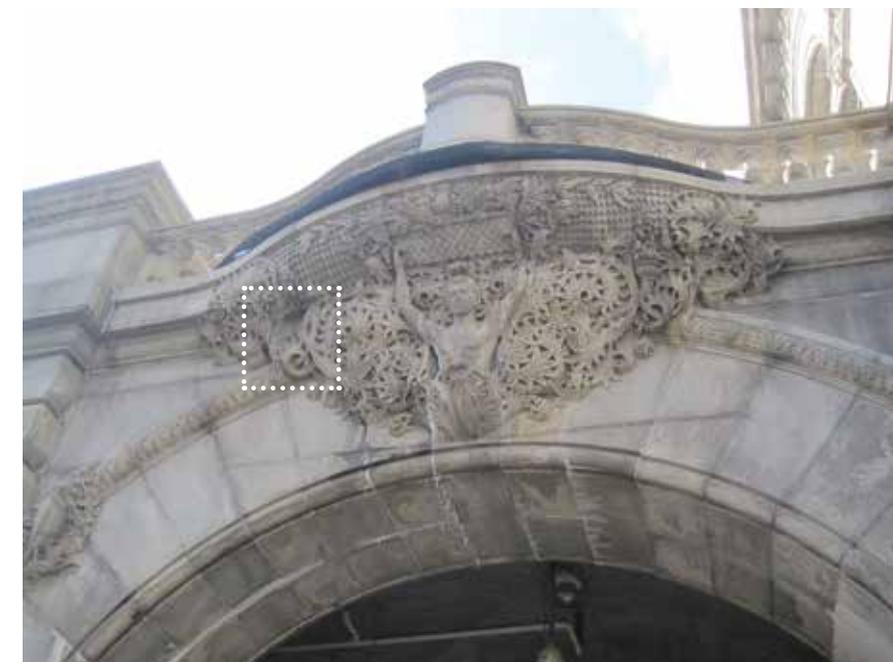
The Landing 2 balustrade opening exposed the cementitious fill below one edge of the landing stone, and we observed evidence of water saturation and freeze-thaw deterioration within the system (Figure 25a). This fill had deteriorated to a sandy consistency and could be removed with a brush for several inches below the stone; even when relatively solid material was encountered, the fill had striated cracks and a flakey consistency (Figure 25b).

The decorative carved stone is also damaged due to water entry and freeze-thaw deterioration, including spalling and exfoliation (Figure 25c). Previous sandblasting campaigns also likely damaged the stone surface. Most prominently, **the decorative carving on the face of the drive arches below Landing 4 is deteriorated with extensive exfoliation of the granite surface and several loose or missing pieces of spalled stone (we removed one roughly 10 pound piece of loose stone by hand over the north arch)** (Figures 25d–e). These areas are covered with water stains and efflorescence; we observed water seeping from the stone despite no recent rain events. These carved areas are covered with black netting, which we understand was installed roughly fifteen years ago after a piece of stone fell onto the driveway below.

Figure 25a Deteriorated mortar below Landing 2 balustrade.

Figure 25c Exfoliated granite at East Portico pier requires resurfacing.

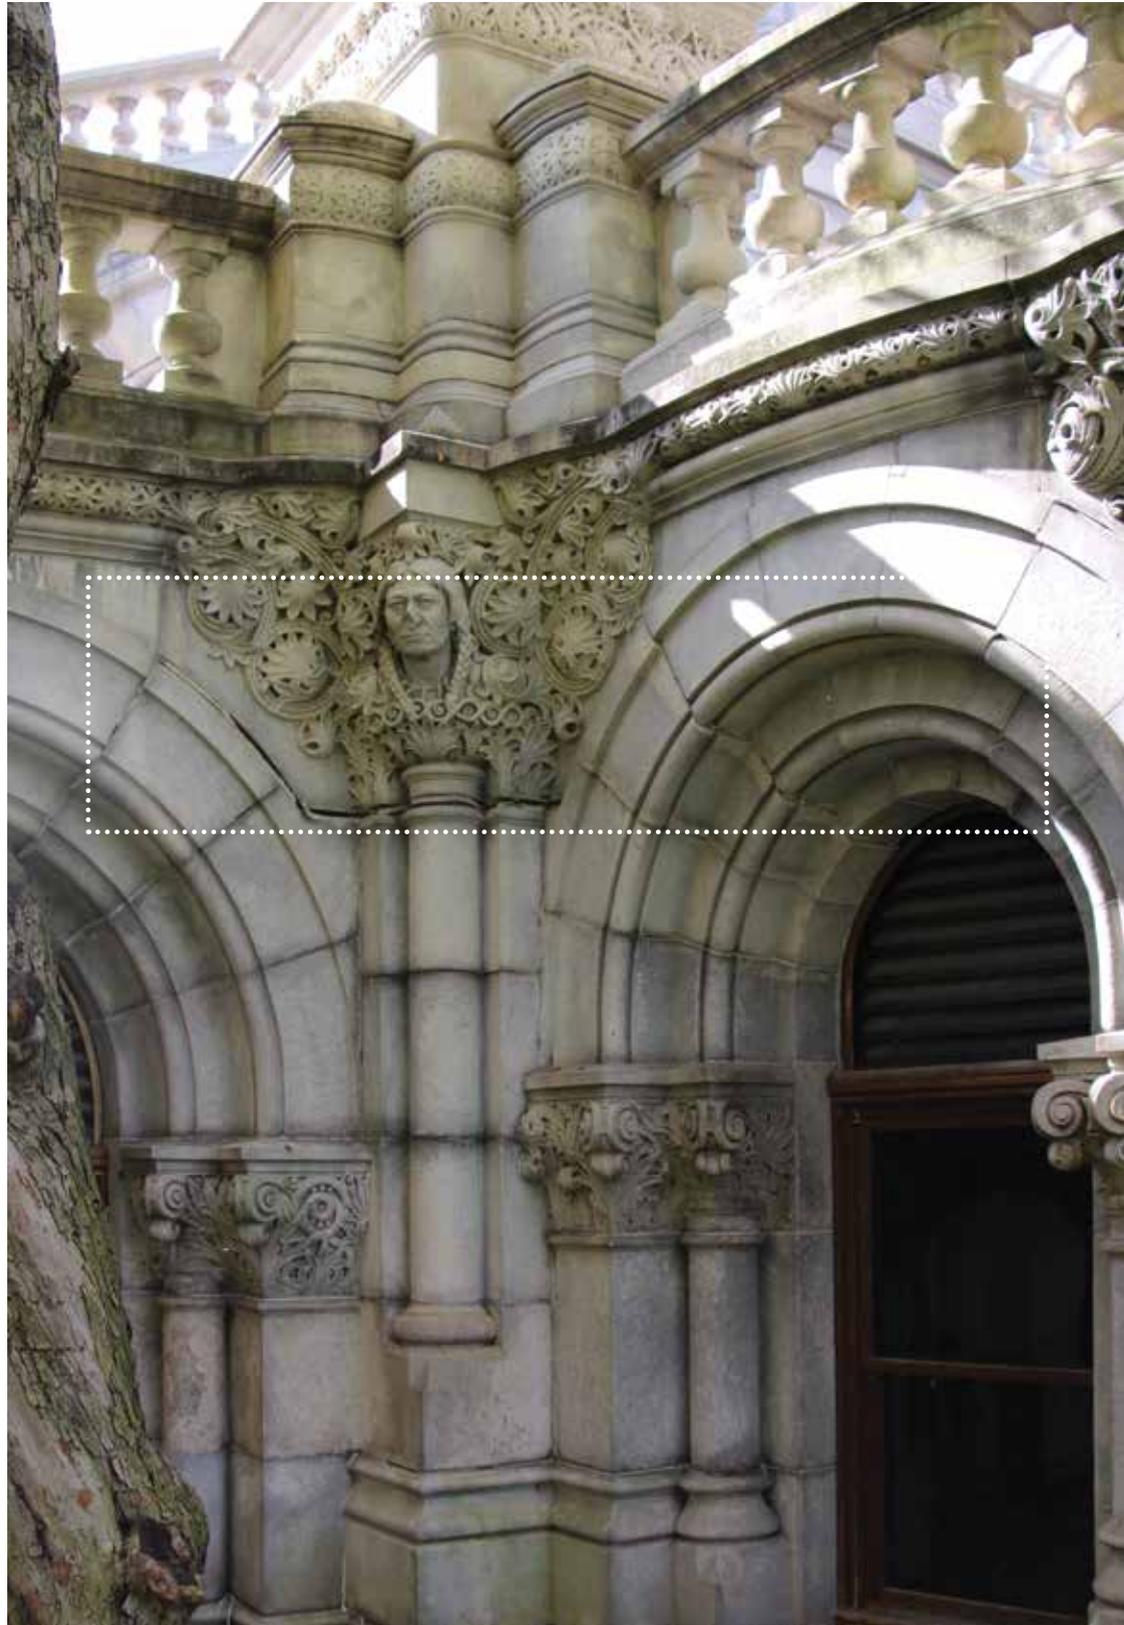
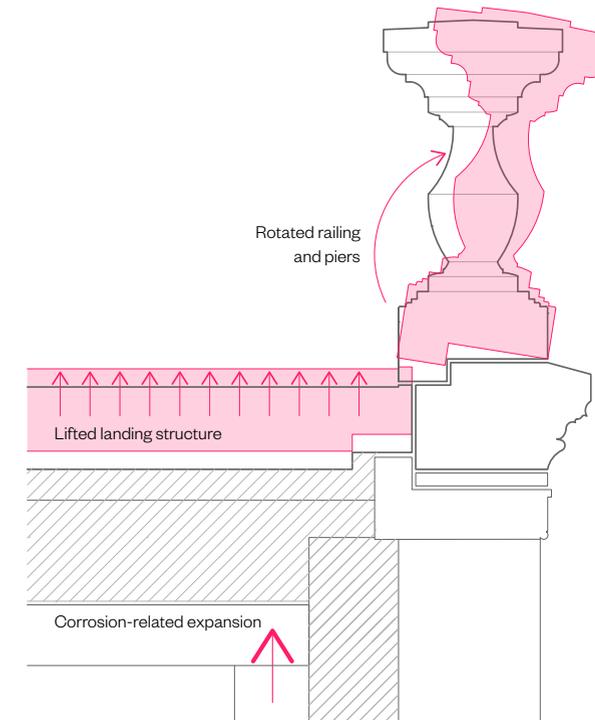
- Figure 29a Landing 2 balustrade rotation mechanism.
- Figure 29b Rotated Landing 2 balustrade.
- Figure 29c Landing 2 balustrade piers and railing stones are keyed together.

On the exterior, there are large open joints along the top portion of the granite stair walls (Figure 28a) that roughly correspond with the location of the interior open joint. This damage is linked to the corrosion-related expansion of the embedded floor beams and precast concrete shims, which is lifting the floor upward. This is also causing rotation of the Landing 2 balustrade (Figures 29a–b), which partially rests on the Landing 2 slabs. **Portions of the balustrade are rotated up to 4.3 degrees out-of-plane. RSA calculated that at a 9 degrees displacement, the balustrade is no longer able to support the code-required railing loads and at a 10 degrees displacement, it becomes unstable and unable to support its own weight.**

While the balustrade is currently several degrees away from these benchmark rotations, we note that corrosion expansion is not linear and rates of corrosion accelerate with time, so that the continued rate of rotation will correspondingly accelerate. In addition to these safety concerns, the differential rotation along the length of the balustrade is causing cracks and spalls, typically where pier and balustrade components are keyed together (Figure 29c).

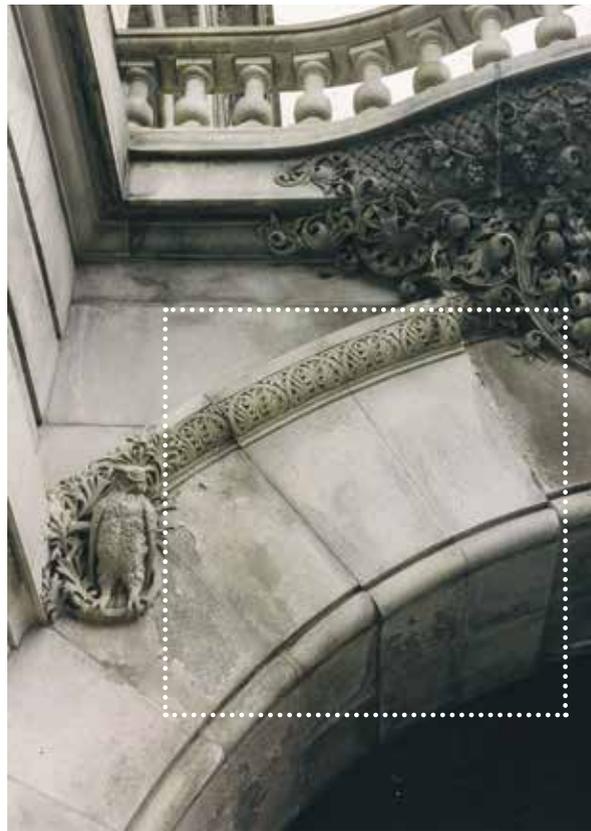
Clockwise from top right:
Figure 32a Current displacement observed at south elevation.
Figure 32b Eastern Approach's south elevation circa 1954.
Figure 32c Displaced arch stones circa 1997.

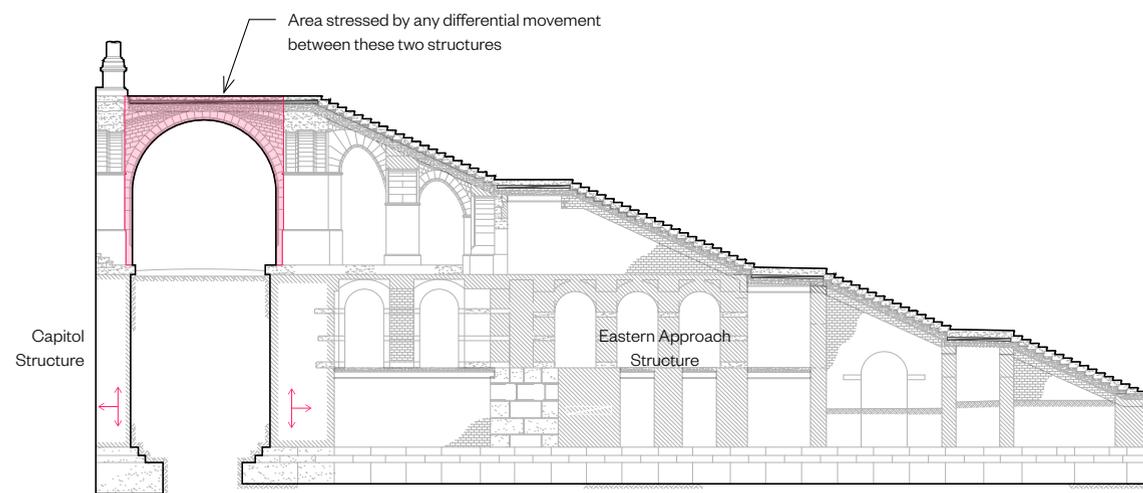
Our conclusion is that the vault and arch displacement is due to previous, but potentially ongoing, differential movement between the separate Capitol and Eastern Approach structures. Ongoing water infiltration in this area exacerbates the displacement by deteriorating mortar joints, which allows the arch stones to slide downward. We believe that differential movement is possible because both the original stair drawings and 1950s drawings show the Eastern Approach structure with an independent mat foundation separated from the Capitol’s foundation by the Executive Ramp (Figure 32d). While we could not verify either of these structures’ foundation condition or configuration in the field, this arrangement makes sense given that the Eastern Approach was constructed decades after the Capitol’s foundation had been laid. As such, the only connection between these two massive masonry structures is the relatively narrow bridge formed by Landing 4 and the granite vaults below.

Figure 32d Capitol and Eastern Approach structures connected only by narrow Landing 4 span.

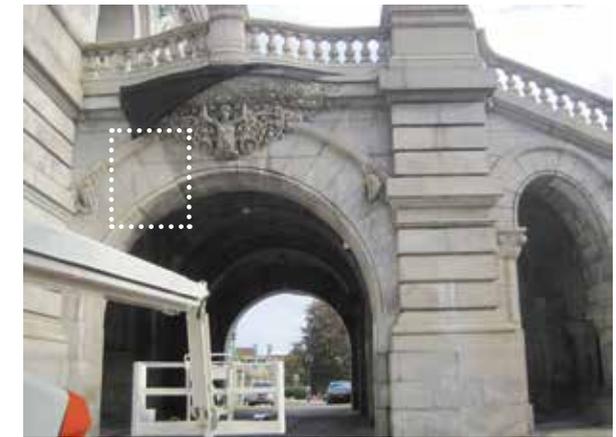
Figure 35a Displaced arch stones at south elevation.

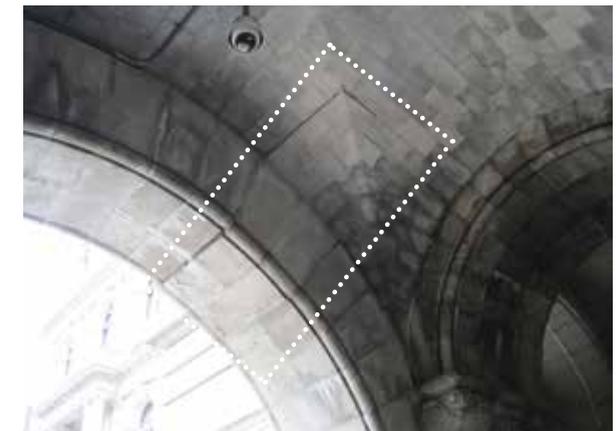
Figure 35b Displaced vault adjacent to arch displacement shown in previous figure.
