ADDENDUM NO. 1 TO PROJECT NO. 45382

HAZARDOUS, CONSTRUCTION, HVAC, PLUMBING, AND ELECTRICAL WORK RENOVATE BUILDING 8, 8TH & 9TH FLOOR STATE OFFICE BUILDING CAMPUS 1220 WASHINGTON AVE. ALBANY, NY

## Revised Pre-Renovation Hazardous Materials Survey Report

**Building 8 & Building 8A**

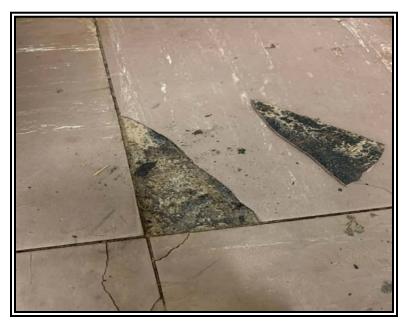
Photo 1: Asbestos-Containing 12" x 12" Floor Tile – Basement (Room A-37)

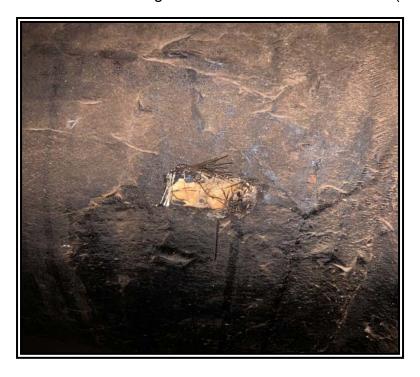
Photo 2: Asbestos-Containing Black Sealant on Pipes – Basement (Main Steam Room)

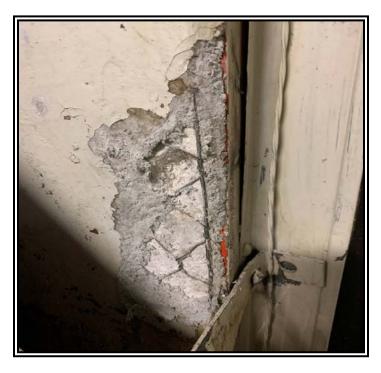
Photo 3: Asbestos-Containing Plaster Insulation under Chicken Wire on Air Handler – 1st Floor (Air Conditioner – 171)

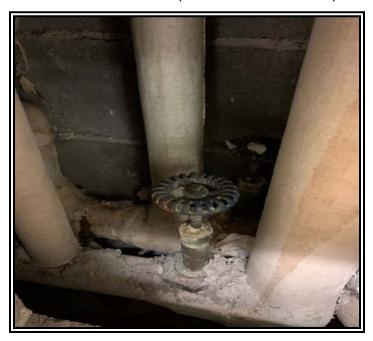
Photo 4: Asbestos-Containing Debris on Pipes/Floor – Ground – 7th Floor (Plumbing Chase in Women's Rest Room)

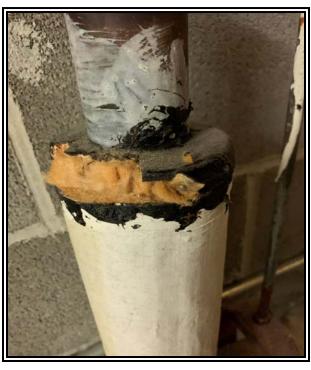
Photo 5: Asbestos-Containing Black Pipe End Cap Sealant – Ground - 7th Floor (Pipe Chase in Men's Rest Room)

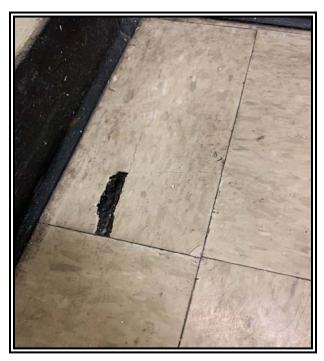
Photo 6: Asbestos-Containing Off-White 12" x 12" Floor Tile with Black Mastic – 4th & 7th Floor (Entrance to Men's Rest Room)

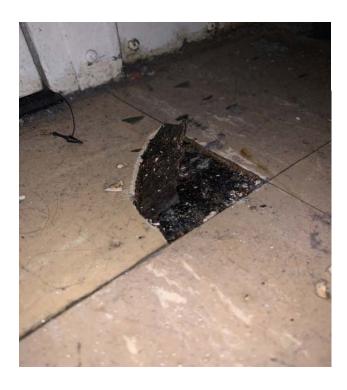
Photo 7: Asbestos-Containing Tan 9" x 9" Floor Tile with Black Mastic (Dominant)

— Throughout Ground - 7th Floor

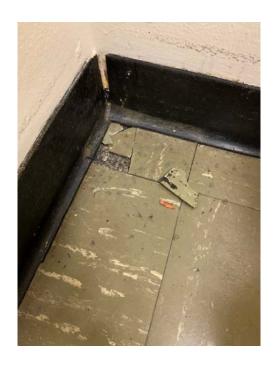
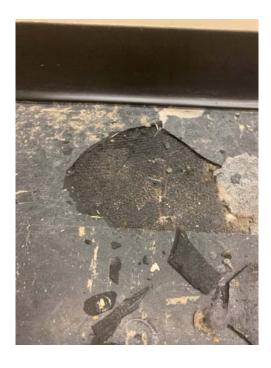
Photo 8 & 9: Asbestos-Containing Olive & Black 9" x 9" Floor Tile with Black Mastic – Throughout Ground Floor – 7th Floor

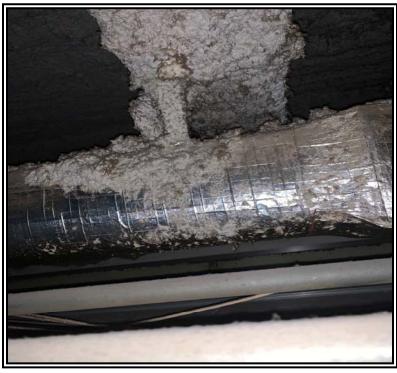
Photo 10: Asbestos-Containing Spray on Fireproofing on Structural Steel Beams and HVAC Ductwork above Ceiling Space –Ground – 7th Floor (Above Ceilings)

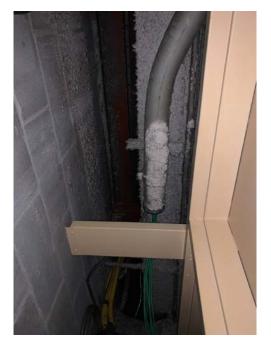
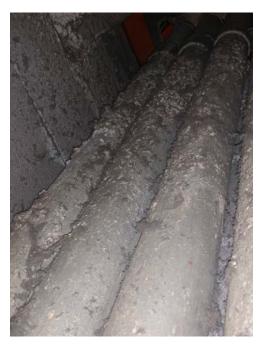
Photo 13 & 14: Asbestos-Containing Spray On Fireproofing Overspray on Conduit, Walls and Structural Steel Beams – Ground Floor – 7th Floor (Electrical Closets)

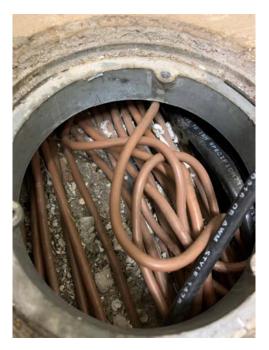
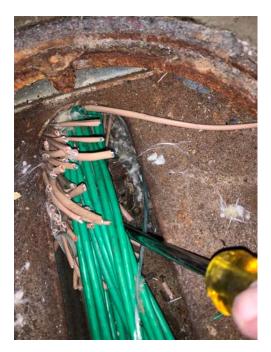
Photo 17 & 18: Asbestos-Containing Spray on Fireproofing Debris in In-Floor Raceway Systems – Throughout Ground – 7th Floor

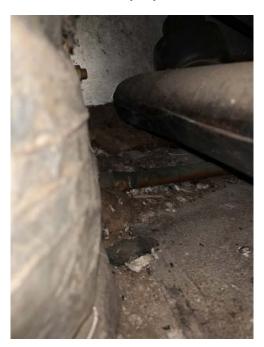
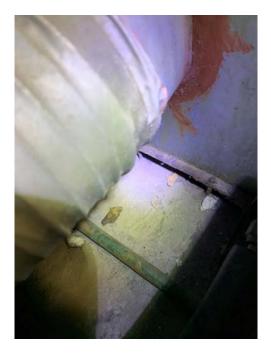
Photo 19 & 20: Asbestos-Containing Spray On Fireproofing Debris inside Perimeter Induction Unit Enclosure's – Ground – 7th Floor

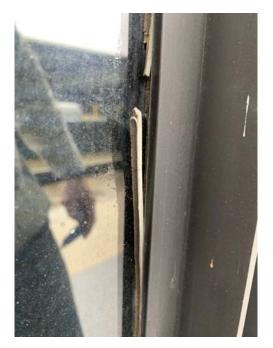
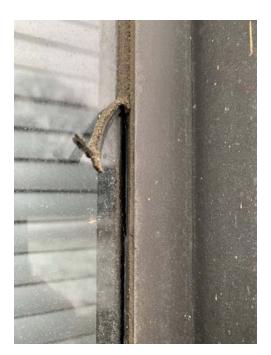
Photo 21 & 22: Asbestos-Containing Window Glazing Compound – Exterior Windows

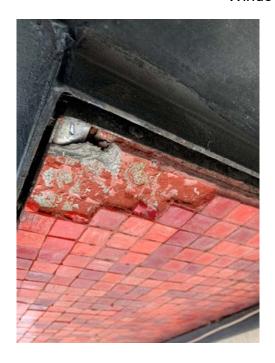
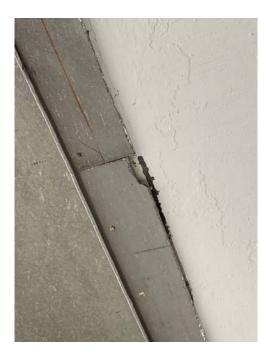
Photo 23 & 24: Asbestos-Containing Cementitious Board –Vestibule Ceiling and Soffits at Loading Dock (Exterior)

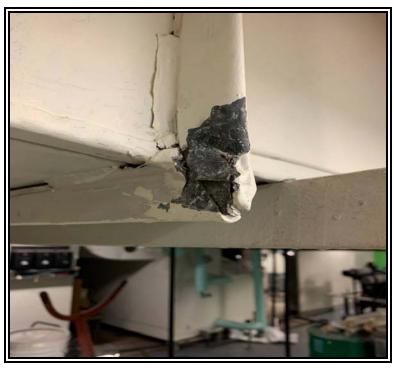
Photo 25: Asbestos-Containing Gray Duct Sealant –Basement (MER North & South)

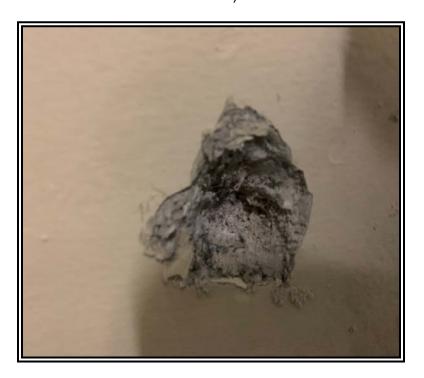
Photo 26: Asbestos-Containing Gray Plaster Insulation on Air Handlers – Basement (MER North)

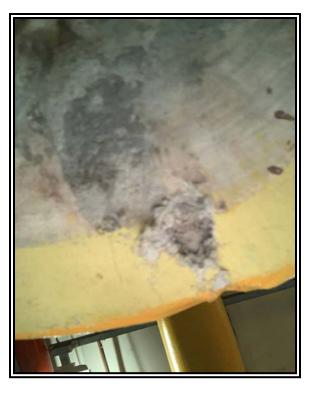
Photo 27: Asbestos-Containing Plaster Pipe End Cap Sealant – Basement (MER North)

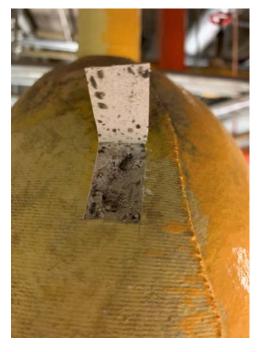
Photo 28 & 29: Asbestos-Containing Job-Molded Plaster Pipe Fitting Insulation – Throughout Basement & Ground Floor

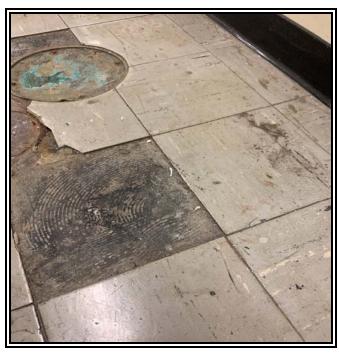
Photo 30: Asbestos-Containing Gray 9" x 9" Floor Tile and Black Mastic – Basement and Ground Floor

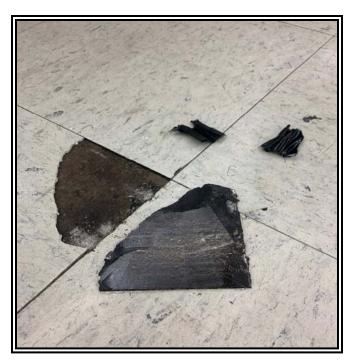
Photo 31: Asbestos-Containing Off-White 12" x 12" Floor Tile – Basement (Main Office Area with Cubicles & OGS Plant Utilities)

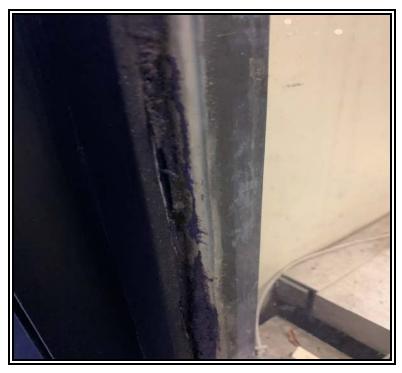
Photo 32: Asbestos-Containing Window Glazing Compound – Exterior Windows

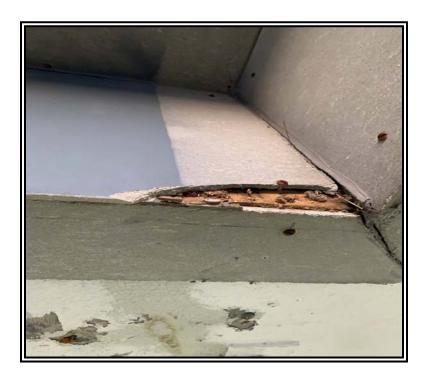
Photo 33: Asbestos-Containing Cementitious Board – Exterior Soffits (Loading Dock)
