## ADDENDUM NO. 2 TO PROJECT NO. 47230

CONSTRUCTION, PLUMBING, HVAC, AND ELECTRICAL WORK  
RENOVATE WARD BATHROOMS, BUILDING 5  
NEW YORK PSYCHIATRIC INSTITUTE  
1051 RIVERSIDE DRIVE  
NEW YORK, NY

**RENOVATIONS SURVEY  
FOR  
ASBESTOS-CONTAINING MATERIALS, LEAD-BASED PAINT & PCBs**

New York Psychiatric Institute  
1051 Riverside Drive  
New York, New York 10032  
Adelaide Project #ARCH-DS:22146.00-IN  
OGS Project #47230

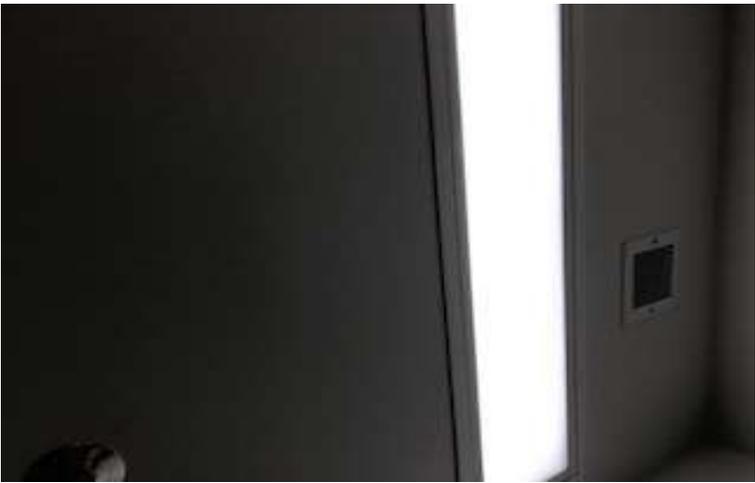
HA	Identified ACM	ACM Location(s)	Approx. Qty.	Condition	Friable? (Yes or No)
Assumed	Electrical Wiring/ Insulation/Components	4 <sup>th</sup> & 5 <sup>th</sup> Floor Ward Bathrooms Throughout	50 LF Each	Good	No

<p>Assumed Typical Light Fixture in Ward Bathrooms – Electrical Wiring/Insulation &amp; Components</p>

- Subpart 56-5(h) of 12 NYCRR Part 56 requires that no demolition, renovation, remodeling, or repair work be commenced by any owner or the owner’s agent prior to the completion of asbestos abatement. Asbestos abatement must be performed by an asbestos abatement contractor that maintains a current asbestos handling license and employs NYSDOL/NYCDEP certified asbestos handlers and supervisors. It is recommended that a 12 NYCRR 56 certified Project Monitor oversee abatement activities.

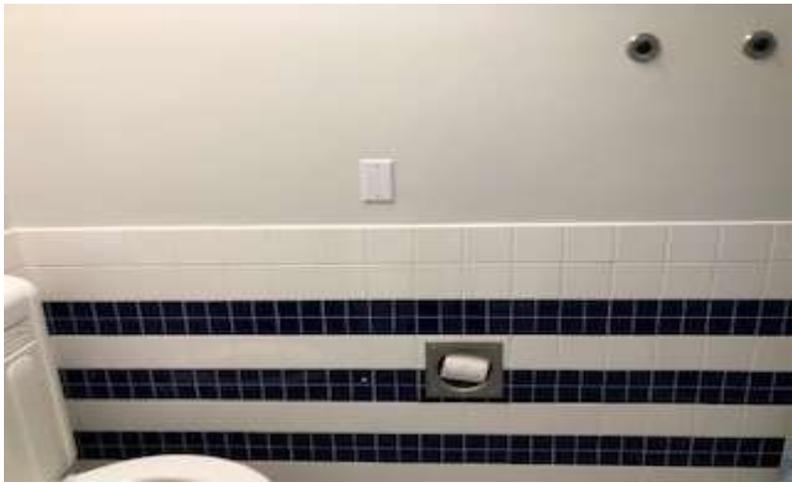
<p>Assumed Typical Outlet Covering in Ward Bathrooms - Electrical Wiring/Insulation &amp; Components</p>

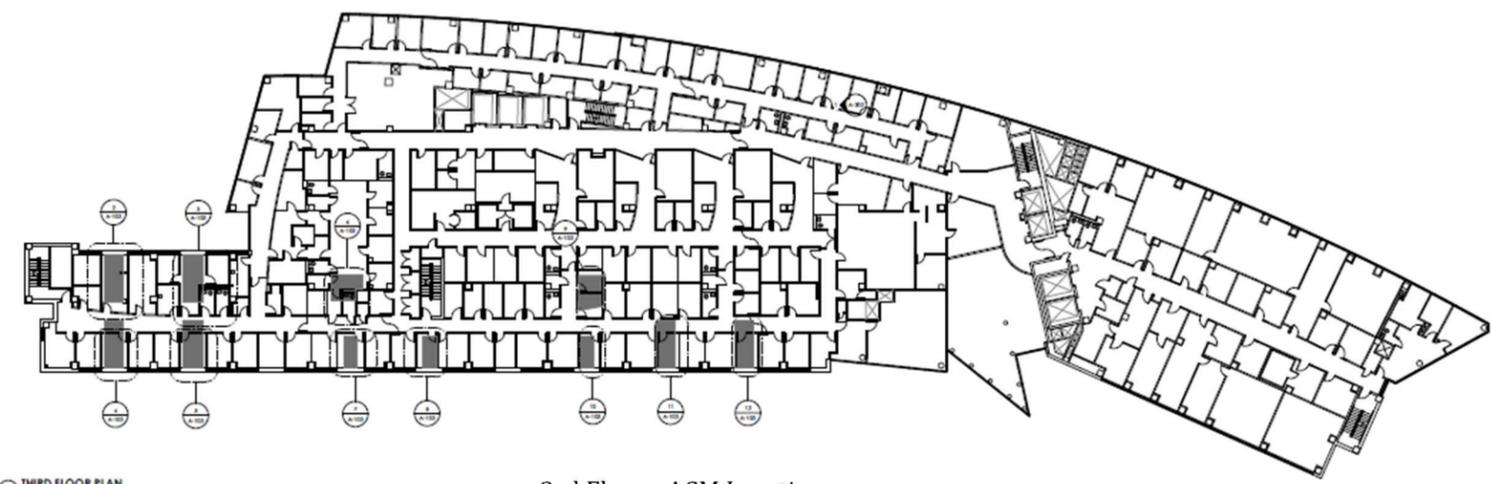
**3rd Floor - ACM Locations**  
\*\*Drawing Not to Scale\*\*

<b>PACM</b>	PACM all Electrical Wiring/Insulation & Components Throughout..
-------------	-----------------------------------------------------------------

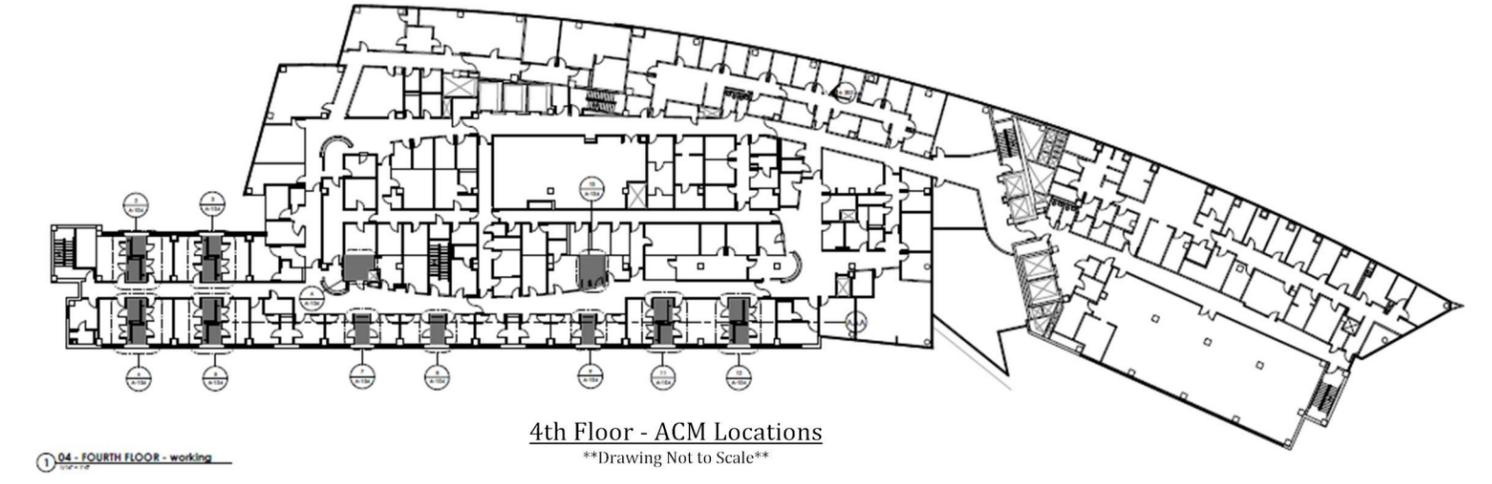
**4th Floor - ACM Locations**  
\*\*Drawing Not to Scale\*\*

<b>PACM</b>	PACM all Electrical Wiring/Insulation & Components Throughout..
-------------	-----------------------------------------------------------------
