## ADDENDUM NO. 1 TO PROJECT NO. 47455

**PLUMBING AND ELECTRICAL WORK  
PROVIDE ELECTRICAL & FIRE PROTECTION UPGRADES  
ARMY AVIATION SUPPORT FACILITY NO. 1  
MACARTHUR AIRPORT  
201 SCHAEFER DRIVE  
RONKONKOMA, NY**

5. PHOTOLOG OF EXISTING ELECTRICAL PANELS: Add the attached Document (pages 1 thru 4) to the Project Manual.

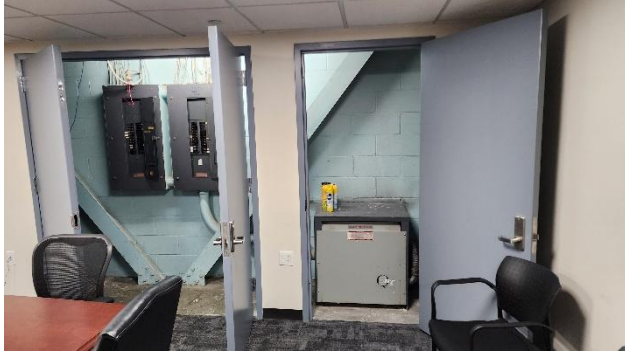
Photo 1: 2<sup>nd</sup> Floor Conference Room North and South Panels

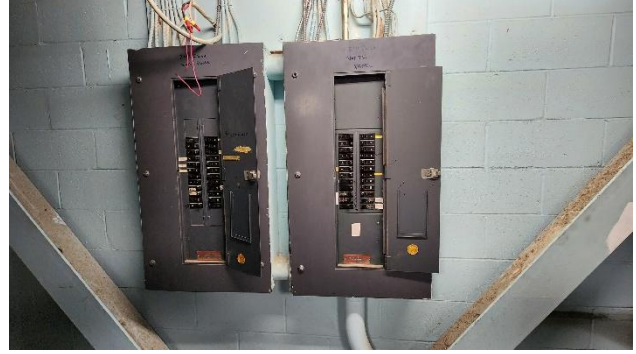
Photo 2: Up close view of the North and South Panels.

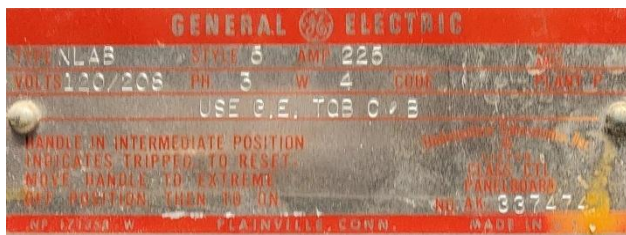
Photo 3: North Panel Nameplate

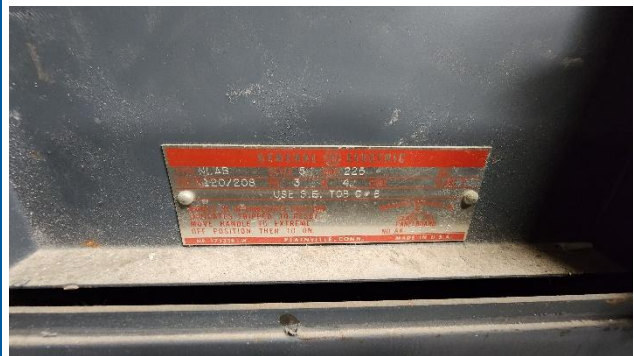
Photo 4: South Panel Nameplate

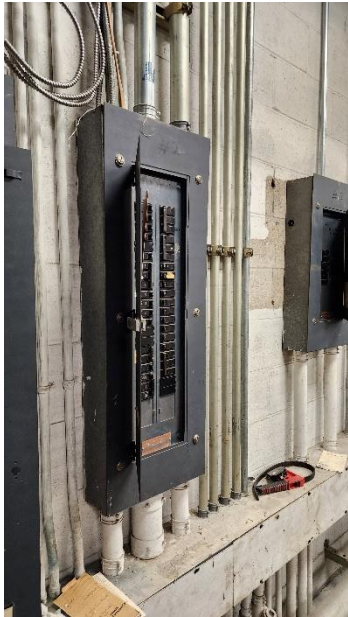
Photo 5: Hangar LP-B #2 Panel

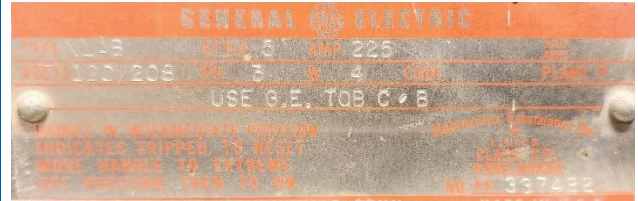
Photo 6: Hangar LP-B #2 Panel Nameplate

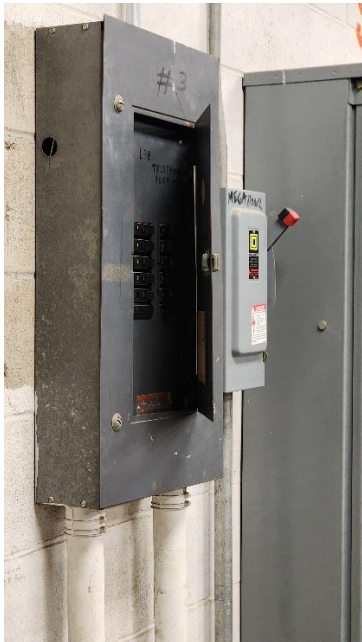
Photo 7: Hangar LP-B #3 Panel

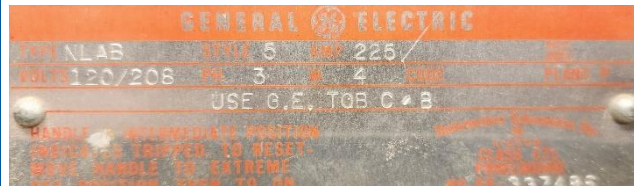
Photo 8: Hangar LP-B #3 Panel Nameplate

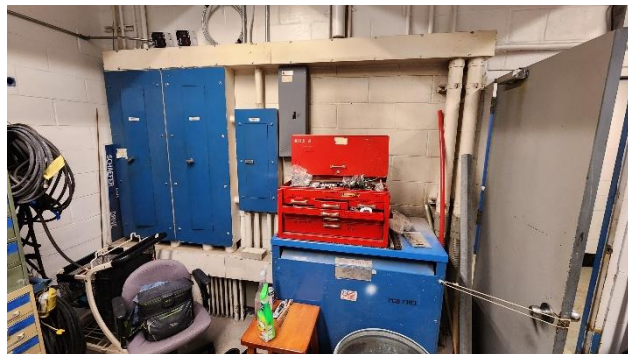
Photo 9: Maintenance Room Panels #3, #2, and #1, respectively.

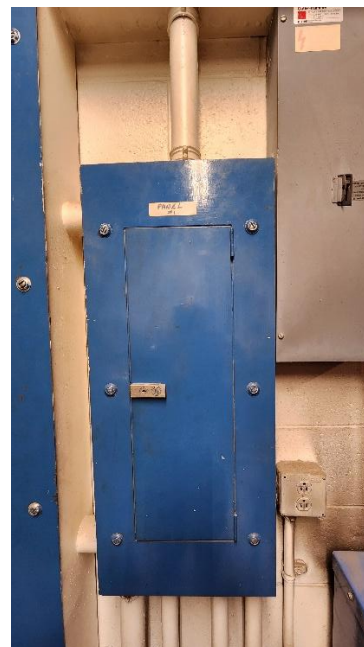
Photo 10: Maintenance Room Panel #1

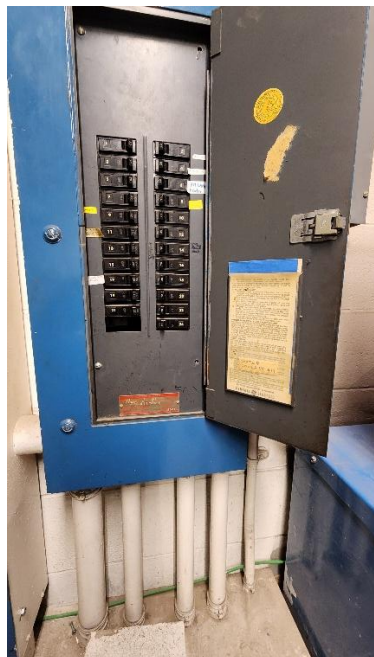
Photo 11: Maintenance Room Panel #1 open

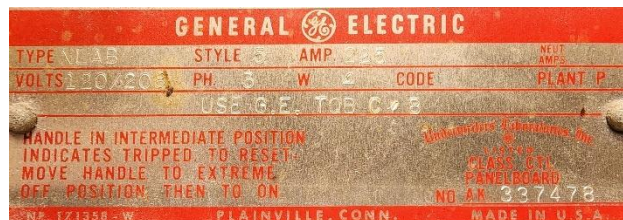
Photo 12: Maintenance Room Panel #1 Nameplate

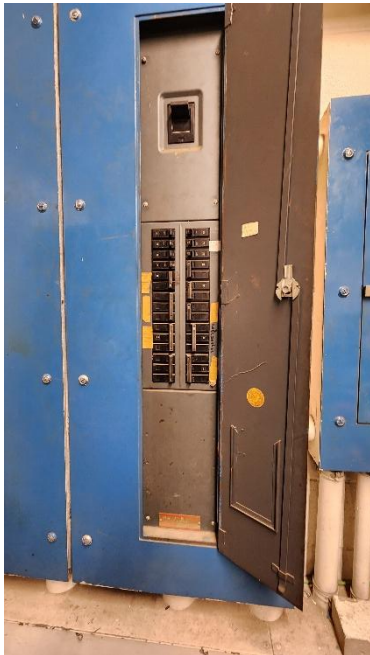
Photo 13: Maintenance Room Panel #2 open

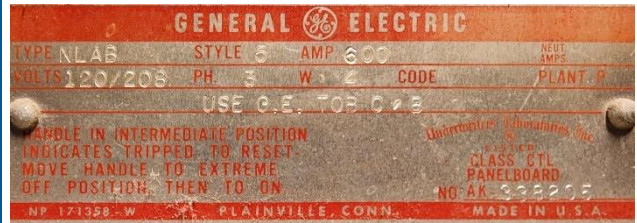
Photo 14: Maintenance Room Panel #2 Nameplate

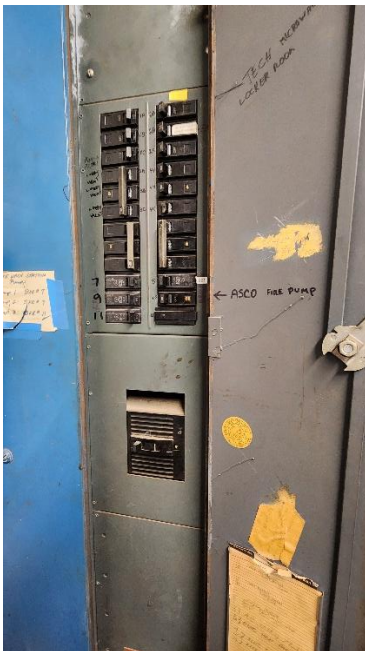
Photo 15: Maintenance Room Panel #3 open

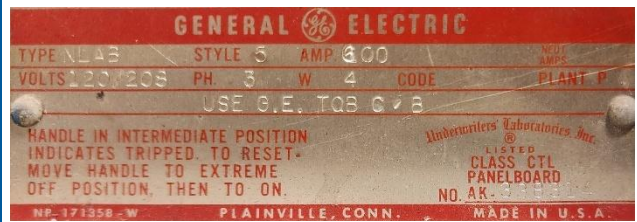
Photo 16: Maintenance Room Panel #3 Nameplate
