Rehabilitate Eastern Approach

New York State Capitol
Albany, New York

OGS Project S6574

Simpson Gumpertz & Heger

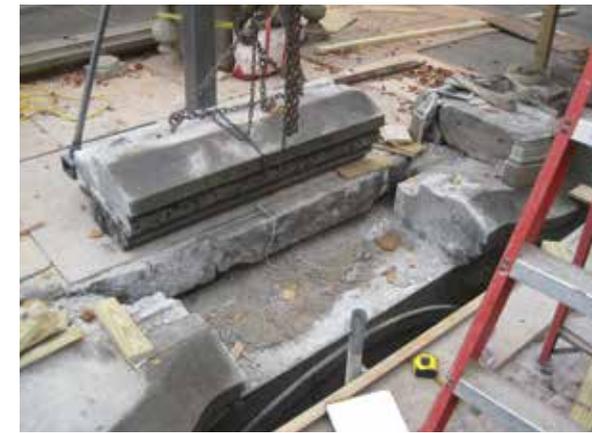
exposed vaults over the driveway. The Landing 1, 2, and 3 walkway surfaces are constructed with deep granite landing slabs (measured at 11 inches thick at Landing 2) (Figure 17a). At Landing 1, the slabs span between two load bearing masonry walls and the undersides are visible from the Lower Basement, where we noted that the underside is unfinished, but relatively planar (Figure 17b). At Landings 2 and 3, the granite rests on a concrete topping and/or mortar setting bed (measured to be 6 inches thick at Landing 2), which is installed over the shored brick jack arch floor system. Flights 1, 2, and 3 are constructed with deep granite treads that bear directly on multiple brick bearing walls (Figure 17c). As with Landing 1, the underside of the flight treads are visible from below, though these stones are rough cut and variable (unlike the landing slabs).

Figure 17a Balustrade stones removed at Landing 2 to expose edge of massive eleven-inch deep landing stone.

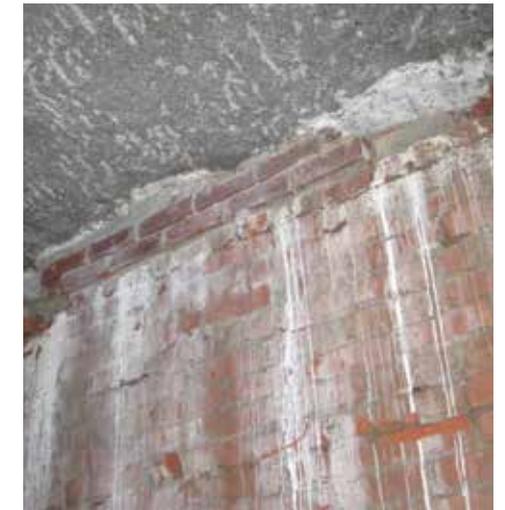
Figure 17b Water stains and rebuilt masonry below Landing 1.

spaces below the stairs and landings, we observed significant deterioration to the top of brick walls supporting the flight and landing stones. Brick below these stones is typically water stained, missing mortar, and often displaced. At our exploratory openings below the Landing 2 floor system, brick could be removed by hand or with hand tools for several courses below, and for multiple wythes into the wall (Figure 24a). **The most significant deterioration is at the north and south side walls below Flight 3, where the innermost wythe is completely failed and bulged away from the wall system. This portion of the wall is in danger of collapse; our opening at this location essentially involved unstacking loose brick by hand (Figures 24b–24d).** At several locations in the Lower Basement, the brickwork below the landing or tread stones has a different brick and mortar color, indicating it was rebuilt (though we found no record of this work), likely due to similar deterioration (Figure 17b).

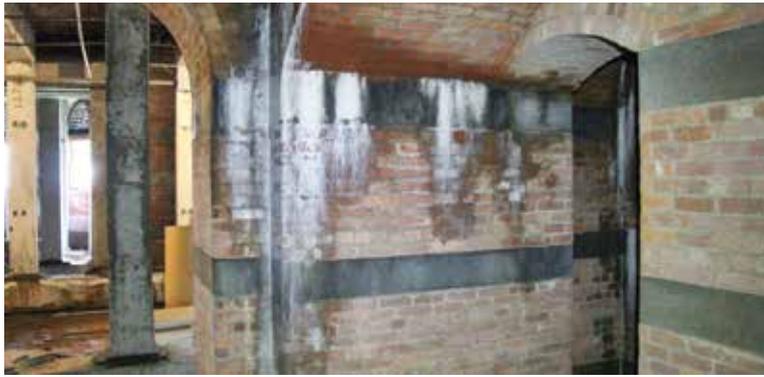
Figure 20a Water stained brick masonry in Upper Basement.

Heavy efflorescence, water staining, and damp masonry is visible throughout the Eastern Approach, and provides evidence as to the extent of leakage into the masonry (Figure 20a). In the Sub-Basement, up to 12 inches of standing water is collected in the perimeter chambers (Figure 20b), likely related to leakage from above and the failed storm water piping. Incidental below-grade leakage may also contribute. Throughout the staircase there are open masonry joints, cracks, and other stone deterioration that allow water entry into the system. Most masonry joints are filled with sealant, which at the balustrade and exterior walls is typically split, crazed, or failed and falling out of the joints (Figure 20c). Sealant at treads and landings (Figure 20d) appears to be a more recent application and is typically intact. In our exploratory openings, we only observed a waterproofing system at Landing 4.

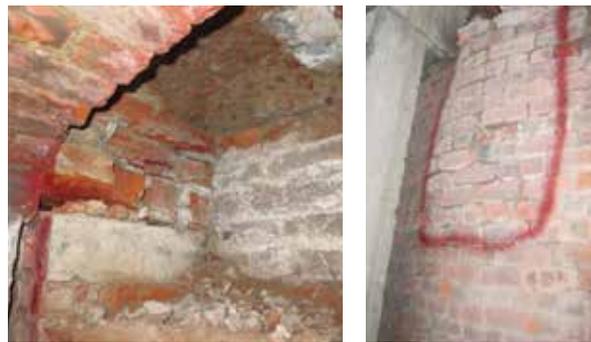
The Landing 2 balustrade opening exposed the cementitious fill below one edge of the landing stone, and we observed evidence of water saturation and freeze-thaw deterioration within the system (Figure 25a). This fill had deteriorated to a sandy consistency and could be removed with a brush for several inches below the stone; even when relatively solid material was encountered, the fill had striated cracks and a flakey consistency (Figure 25b).

Figure 25a Deteriorated mortar below Landing 2 balustrade.

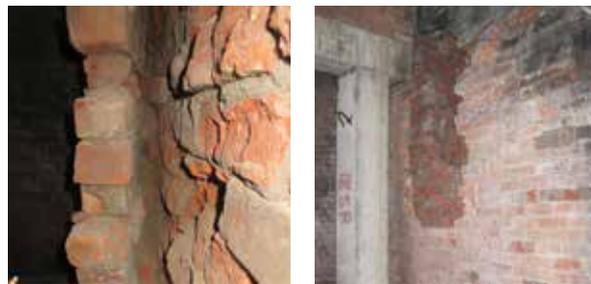
Figure 25b Cementitious fill below landing stone is friable.

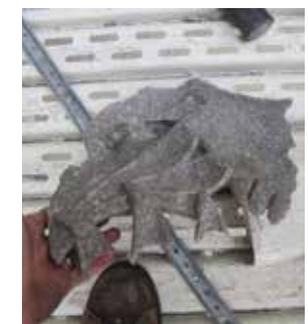
Figure 25e Loose spall removed from the location that is noted on Figure 25d.

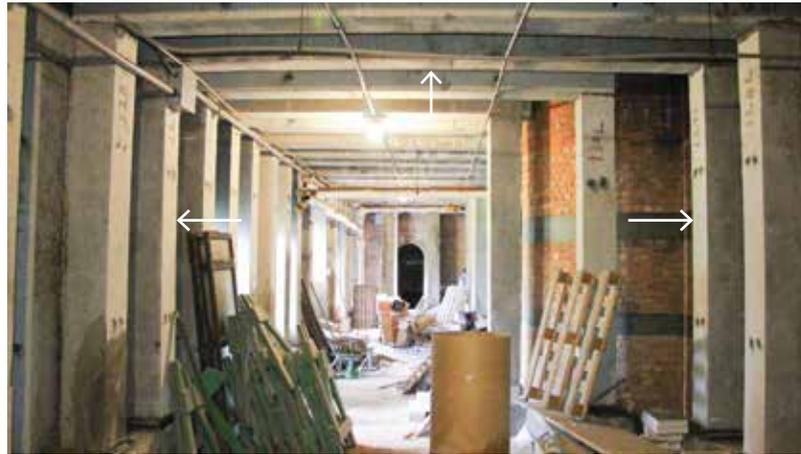
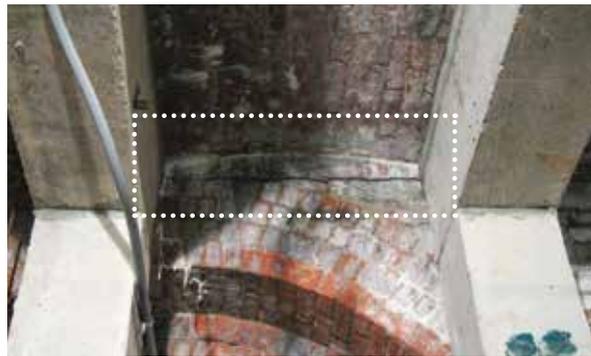
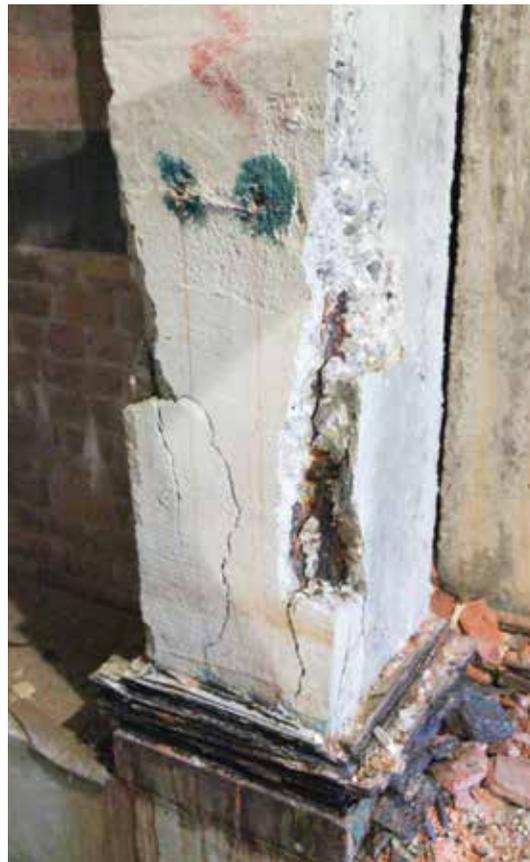
Figure 26a Pre-cast shoring below Landing 2.

Figure 26b Corrosion on shoring baseplate and shims.

Figure 26c Damaged pre-cast shoring member.

Figure 26d Open crack below lifted Landing 2 structure.

Components of the pre-cast concrete shoring system are now corroding as well. The shoring consists of a pre-cast concrete cap beam located below each original floor beam, which is held in place by two pre-cast columns supported on a pre-cast sill beam. Steel baseplates and wedge shims were used between the column and sill beam to field fit the pre-cast tight to the underside of the brick jack arch floor system. These baseplates and shims typically have extensive rust scale (Figures 26a–b). The pre-cast units themselves are generally intact, though many are cracked (Figure 26c) or spalling due to corroding reinforcement (89 of 133 units at the basement level have some damage; we did not comprehensively survey each sub-basement unit's condition).

In the masonry walls below Landing 2, the bed joint aligned with the bottom flange of the jack arch floor beams is consistently cracked, open, and visibly larger (Figure 26d) than other joints (roughly 1 inch wide, though it varies somewhat along the length).

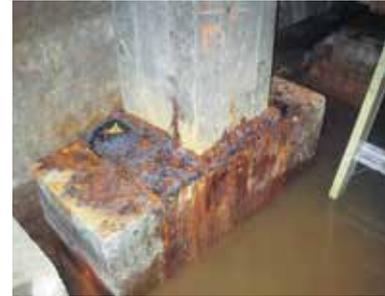
Deterioration Due To Corrosion The significant water entry is causing widespread corrosion, most significantly at the landing and basement floor systems, but also at incidental anchors and embedded lintels, such as at the straps and through-wall anchors at each Upper Basement window pier. Left unchecked, corrosion will continue and may destabilize portions of the stair structure, though we see no immediate hazards at this time. Eliminating leakage from above will greatly reduce the rate of corrosion; however, some corrosion could continue given the damp environment.

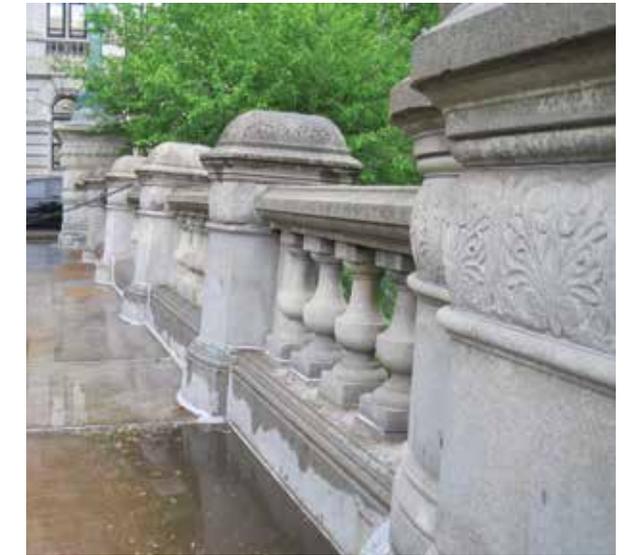
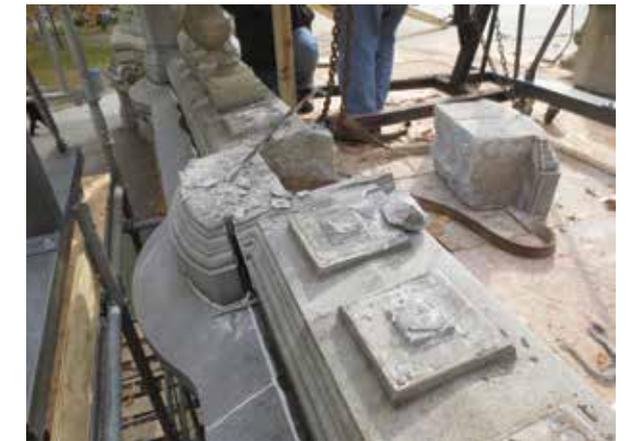
- Figure 29a Landing 2 balustrade rotation mechanism.
- Figure 29b Rotated Landing 2 balustrade.
- Figure 29c Landing 2 balustrade piers and railing stones are keyed together.

On the exterior, there are large open joints along the top portion of the granite stair walls (Figure 28a) that roughly correspond with the location of the interior open joint. This damage is linked to the corrosion-related expansion of the embedded floor beams and precast concrete shims, which is lifting the floor upward. This is also causing rotation of the Landing 2 balustrade (Figures 29a–b), which partially rests on the Landing 2 slabs. **Portions of the balustrade are rotated up to 4.3 degrees out-of-plane. RSA calculated that at a 9 degrees displacement, the balustrade is no longer able to support the code-required railing loads and at a 10 degrees displacement, it becomes unstable and unable to support its own weight.**

While the balustrade is currently several degrees away from these benchmark rotations, we note that corrosion expansion is not linear and rates of corrosion accelerate with time, so that the continued rate of rotation will correspondingly accelerate. In addition to these safety concerns, the differential rotation along the length of the balustrade is causing cracks and spalls, typically where pier and balustrade components are keyed together (Figure 29c).

- Repair and/or replace shoring at the Flight 3 deteriorated walls to maintain adequate support of tread stones and prevent localized brick masonry collapse.
- Monitor the rotated Landing 2 balustrades; provide signage or close landing if these railings rotate beyond the point of supporting code-required loads (calculated at 9 degrees past plumb).
- Continue to maintain netting over the Executive Ramp until repairs are complete and water ingress at Landing 4 is mitigated. This netting is necessary to mitigate potential falling hazards.

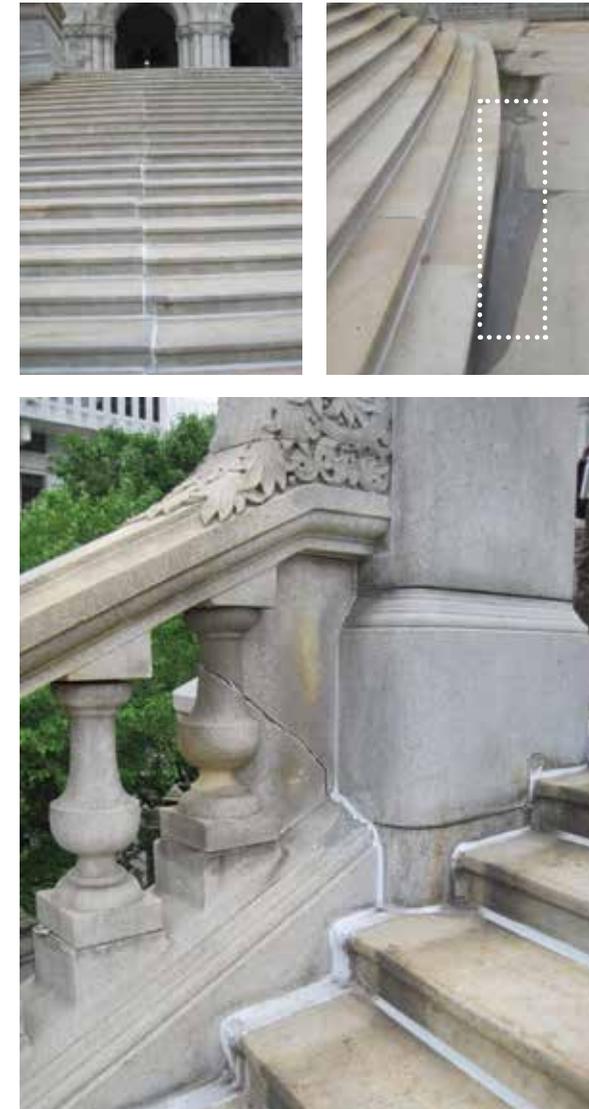
- **Treads Stones:** 79 of approximately 390 stair tread stones are cracked (Figure 31a); the majority of these cracks (87 percent) were shown on the 1950s drawings and thus occurred prior to 1952. Other than cracks, the granite treads are typically intact and in good condition with limited wear.

- **Landings Stones:** 8 of 74 landing stones are cracked (Figure 31b). Seven of these cracks are large apparent through-cracks in Landing 2 stones adjacent to the upper stair structure; the eighth is a small corner crack where a Landing 2 stone abuts the south railing. These existing cracks are not shown on the 1950s drawings and all appear to be due to distress caused by the jacking of this landing level due to the corrosion issues discussed above. The 1950s drawings do show three other cracked landing stones, all of which were either partially replaced or repaired. Other than cracks, the granite landing stones are typically intact and in good condition with limited wear.

- **Stair Walls and Balustrade:** The granite cladding on these walls is generally intact, though we observed approximately 36 stones with spalls or failing patches, 33 cracked stones, and 42 displaced stones – most of this distress is located near the top of the wall or within the balustrade bases and piers (Figure 31c).

Figure 31a Typical cracked tread stones at Flight 4.

Figure 31b Cracked Landing 2 stones at interface with Flight 3.

Figure 31c Typical balustrade crack at Flight 1.

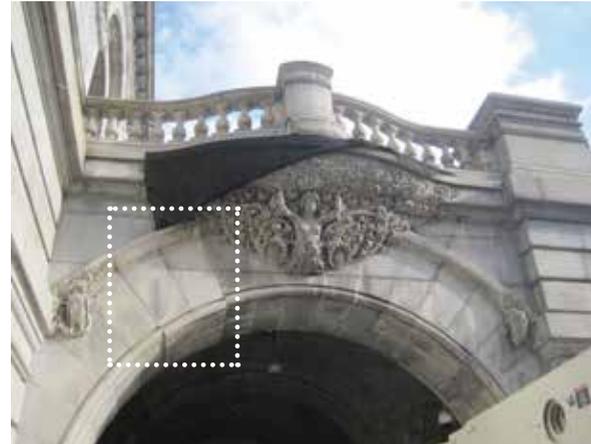
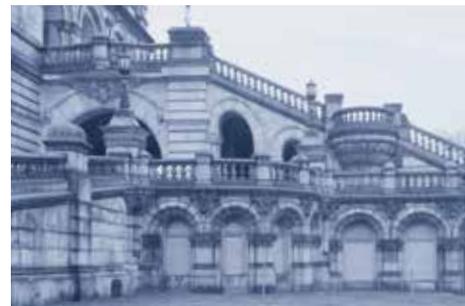
Clockwise from top right:
Figure 32a Current displacement observed at south elevation.
Figure 32b Eastern Approach's south elevation circa 1954.
Figure 32c Displaced arch stones circa 1997.

Arcade Vaults There are five areas of displaced granite in the vaults and arches of the Arcade, the most noticeable of which are two stones in both the north and south archways (Figure 32a). This displacement is symmetrical about the staircase, though the south arch stones have greater displacement (roughly 2 inches out of original position). This displacement is not clearly visible in historic photos (Figure 32b) or explicitly noted in the 1950s drawings (these drawings do note “open joints” at the location of the two displaced arch stones). When compared to photographs taken during our 1997 inspection this condition appears relatively unchanged (Figure 32c). This is the only significant area of distress that is not directly attributable to leakage or rust jacking, though water infiltration may worsen these conditions. Based on RSA’s structural analysis, the displacement is not due to any deficiency in the masonry’s designed configuration.

Our conclusion is that the vault and arch displacement is due to previous, but potentially ongoing, differential movement between the separate Capitol and Eastern Approach structures. Ongoing water infiltration in this area exacerbates the displacement by deteriorating mortar joints, which allows the arch stones to slide downward. We believe that differential movement is possible because both the original stair drawings and 1950s drawings show the Eastern Approach structure with an independent mat foundation separated from the Capitol’s foundation by the Executive Ramp (Figure 32d). While we could not verify either of these structures’ foundation condition or configuration in the field, this arrangement makes sense given that the Eastern Approach was constructed decades after the Capitol’s foundation had been laid. As such, the only connection between these two massive masonry structures is the relatively narrow bridge formed by Landing 4 and the granite vaults below.

- The vertically displaced arch stones indicate a loss of compression in the arch, allowing these wedged stones to slide downwards. In a load bearing masonry arch, the only ways to lose compression are widening the arch, or lifting or lowering one side of the arch. These two conditions require lateral or vertical movement, respectively, of one or both of the two structures on either side of the arch.

The magnitude of the movement to date has not undermined the structural performance of the vaults, and further deterioration will likely be limited by managing water entry from above. We recommend continued monitoring to gauge if further displacement is occurring over time.

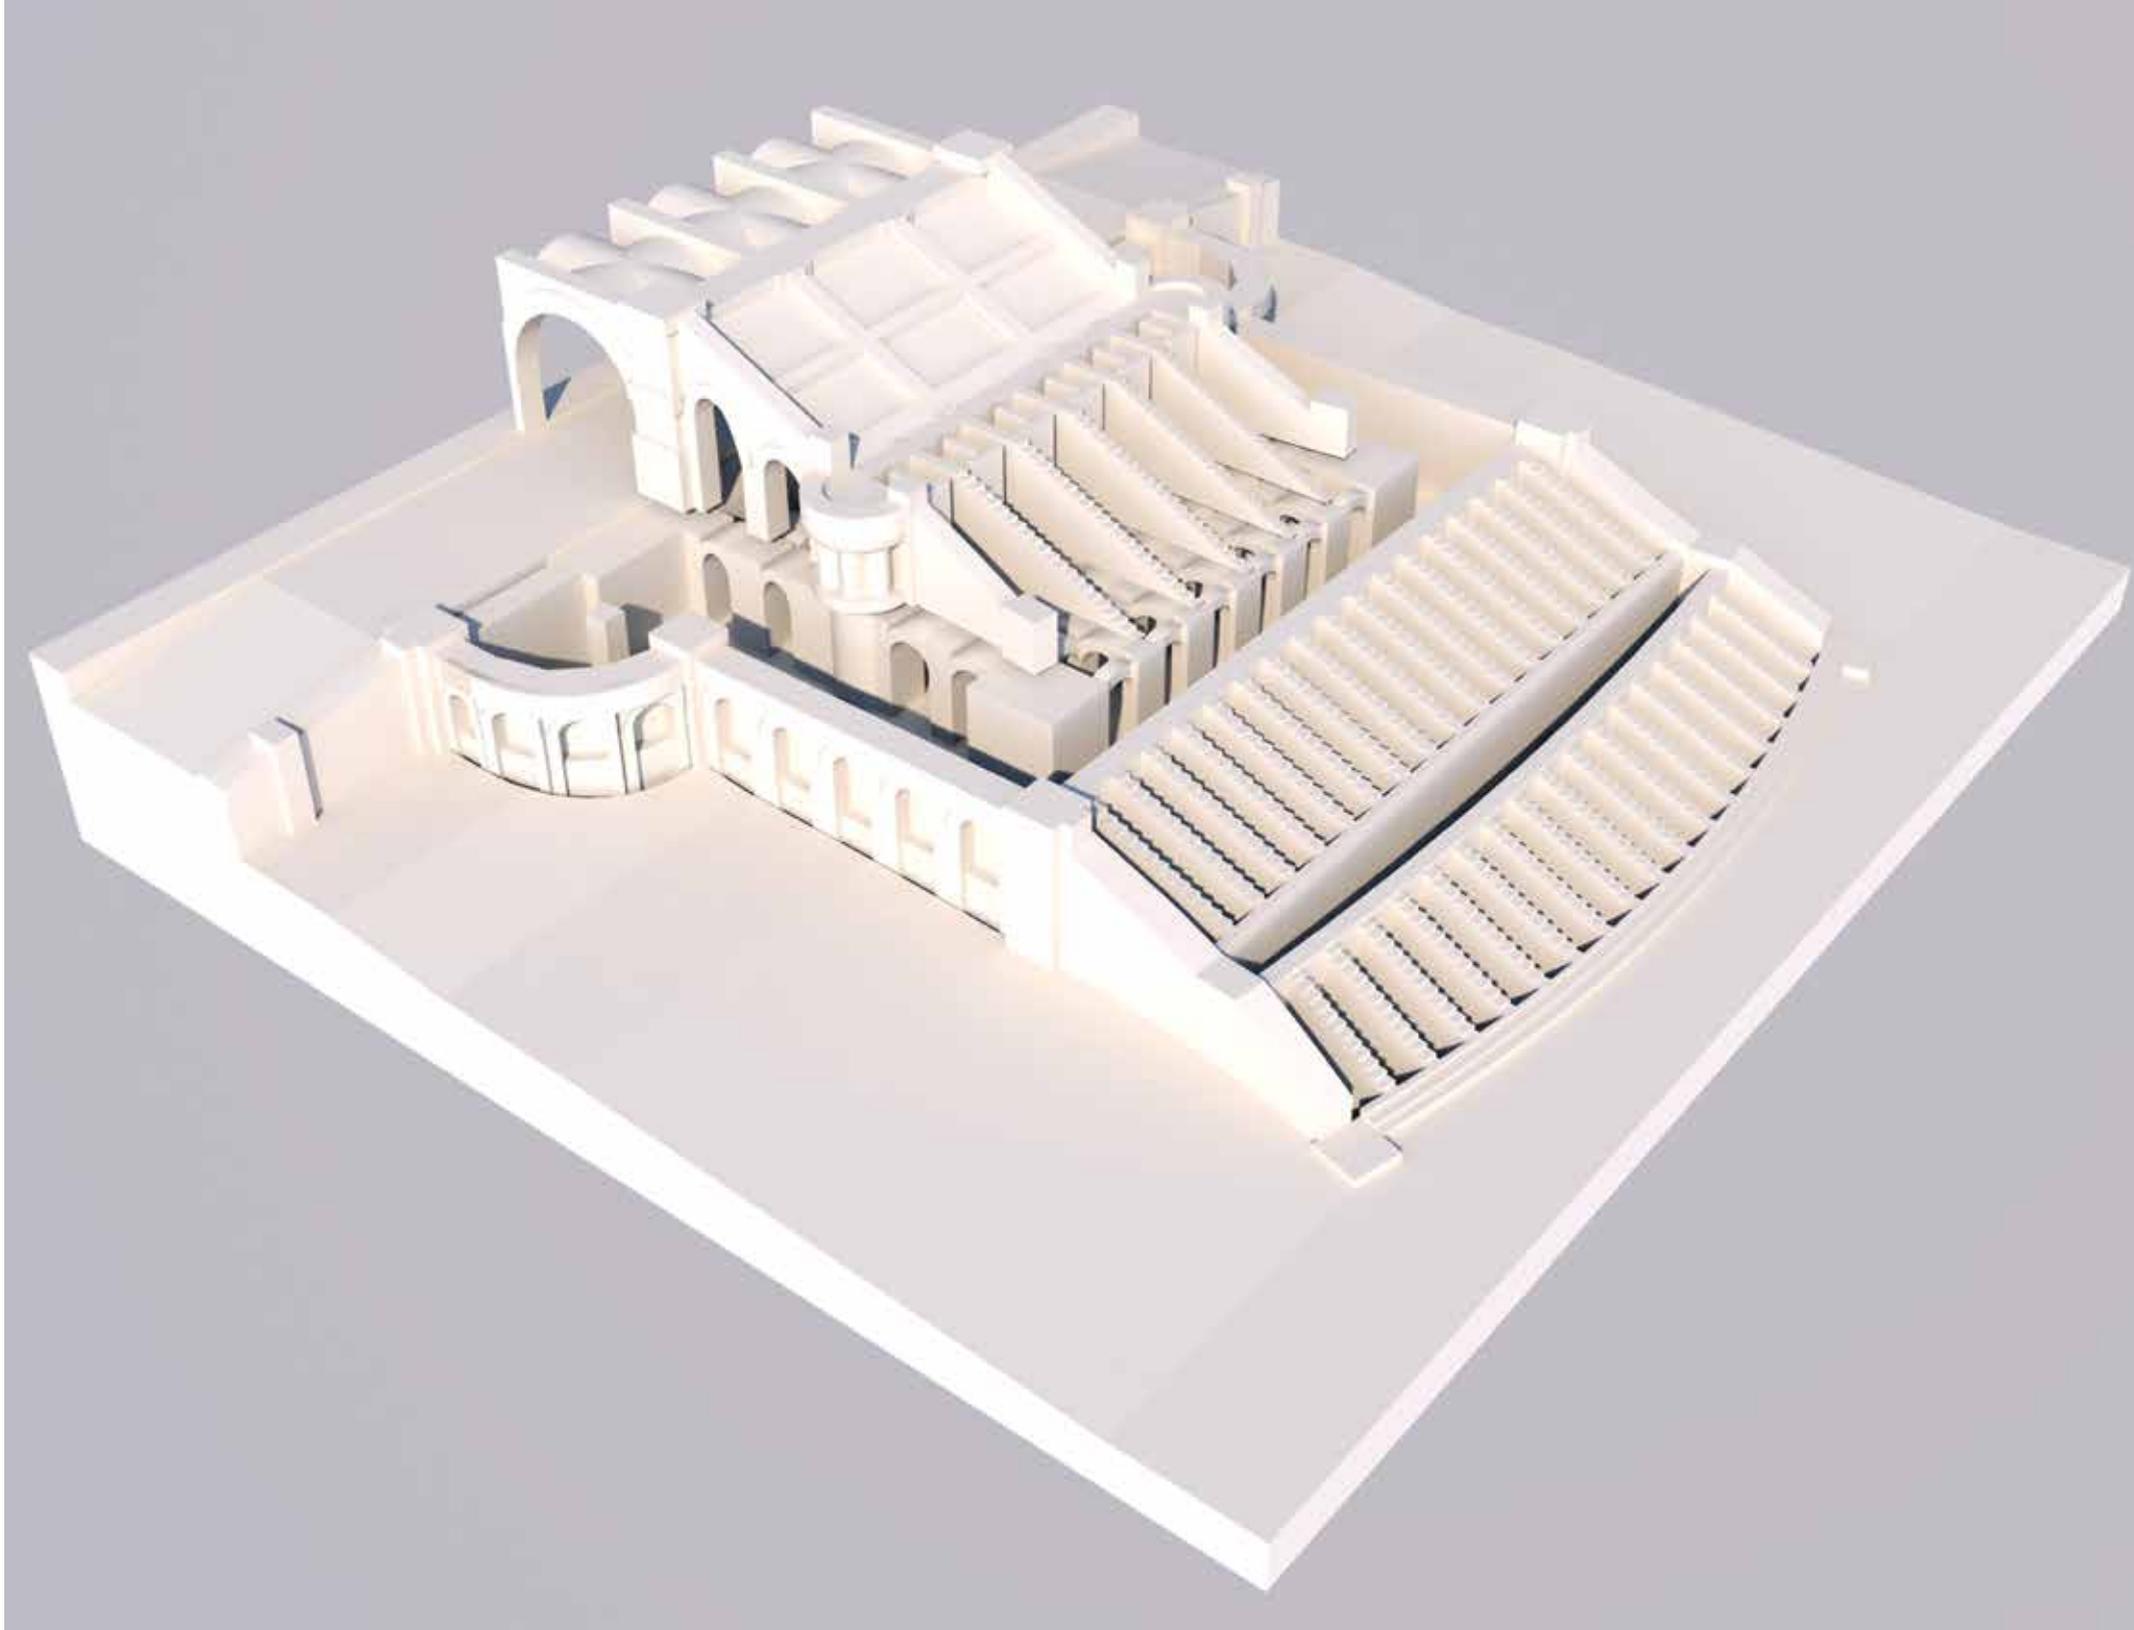
Figure 36a Extent of structure to remaining after proposed removal work.

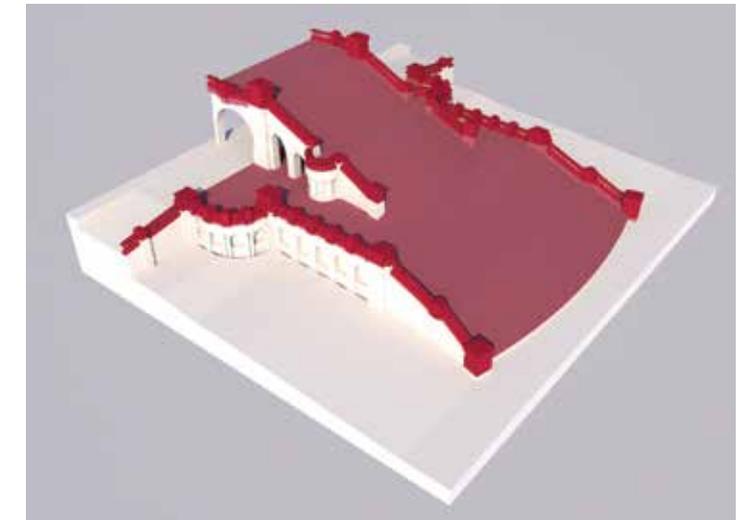
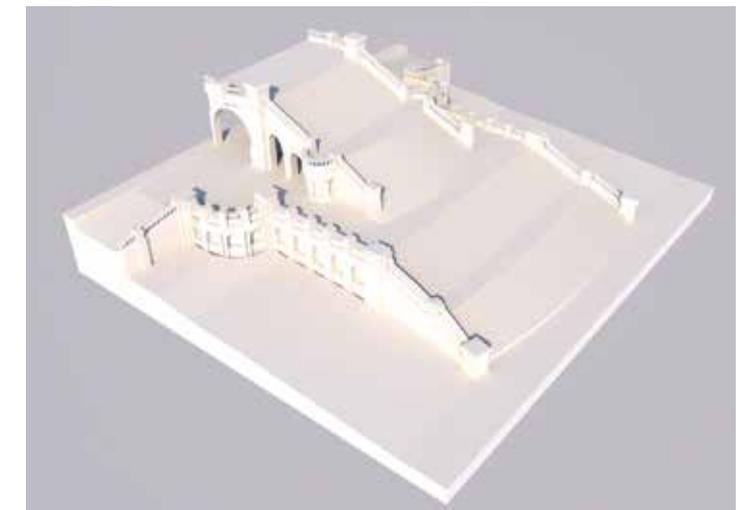
Figure 37a Extent of proposed waterproofing and flashing work.

Figure 37b Completed work will restore Eastern Approach to original appearance.

Repair Remediations The only way to reliably prevent water infiltration through masonry in horizontal applications, without altering the appearance, is to provide a dedicated waterproofing or flashing system below the stone. In concept, this is similar to the approach taken at Landing 4 more than sixty years ago; however, the existing stone landing slabs should be reinstalled to maintain the historic fabric and staircase appearance, and the waterproofing system should include a means of membrane-level drainage to greatly increase the durability and lifespan of the waterproofing membrane used.

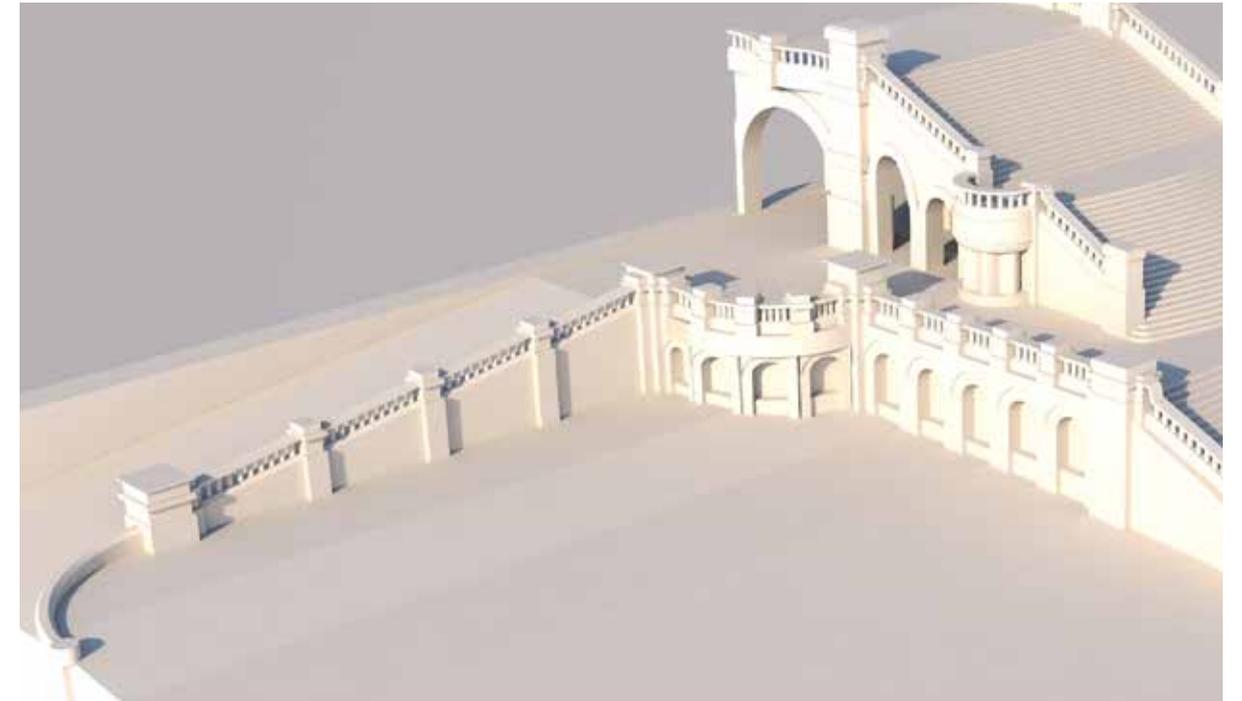
Retaining Walls and Curbs Water enters the masonry retaining walls through failed sealant in stone joints and from ground water in the poorly drained soil below the drive surface. This water entry is causing stone damage, including rotation of the granite balustrade due to general mortar joint deterioration and freeze-thaw jacking and ratcheting due to ice lenses in the horizontal bed joints (upper portion of piers have rotated outward toward the East Capitol Park by roughly three degrees, typically the point of rotation aligns with the driveway level) (Figures 39b and 41a). This ratcheting occurs when collected water freezes and expands, causing the masonry to lift incrementally. As the ice melts, debris partially fills the joint and prevents the stone from settling back into place. This repetitive process accelerates with time, as the displaced stones allow more water entry. In addition, the displacement results in localized stress due to differential movement, which is causing cracks and spalls in isolated balustrade and wall stones.

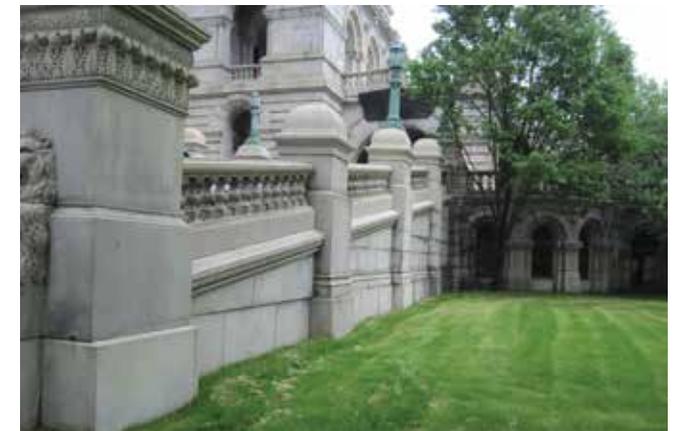
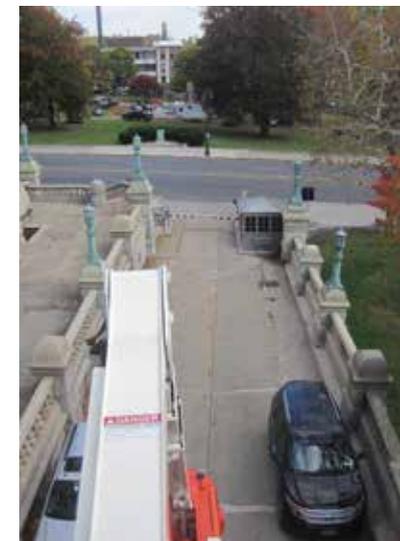
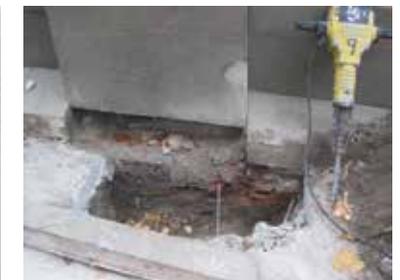
The Executive Ramp is an approximately 300 foot long, ramped driveway connecting Washington Avenue and State Street, and running below the upper portion of the Eastern Approach (Figure 39a). The west edge of the ramp abuts the Eastern Promenade masonry walls. Granite masonry retaining walls with granite balustrades, which connect with the lower Eastern Approach walls, bound the east edge of the ramp (Figure 39b). The drive surface is a 4.5-inch, reinforced concrete slab on grade, with a granite curb separating the drive surface from the retaining wall. All retaining wall and curb joints are filled with sealant, which is typically split, crazed or failed.

Immediately below the drive surface is a 1.5-inch gravel sub-base. The soil below is a moist, grayish brown sand and gravel material with very little fines and moderate drainage properties. The soil abuts the retaining wall, which lacks any dedicated drainage system or damp proofing to limit ground water infiltration into the wall (Figure 39c).

Figure 39a Executive Ramp and tie-in to Eastern Approach.

Figure 39b South retaining wall with outwardly rotated piers.

Figure 39c Executive Ramp exploratory opening.

Figure 39d Guard booth and gate at Washington Avenue entry.

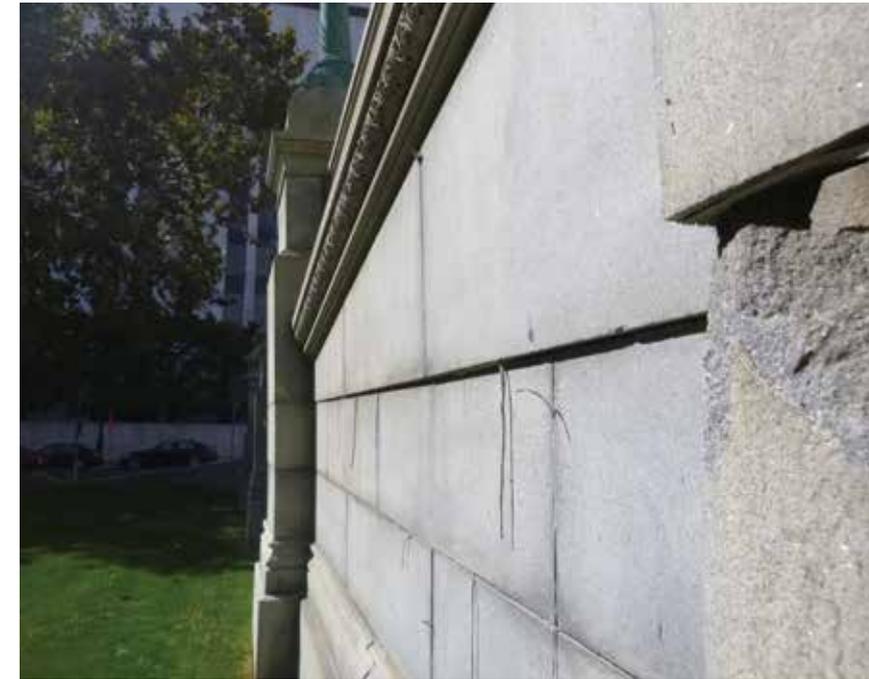
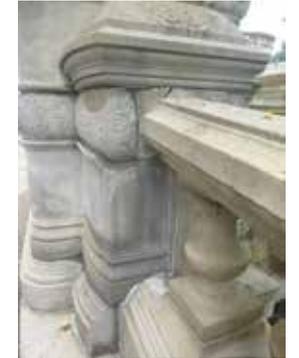
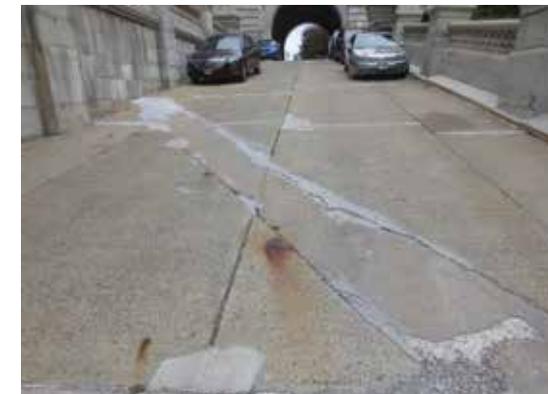
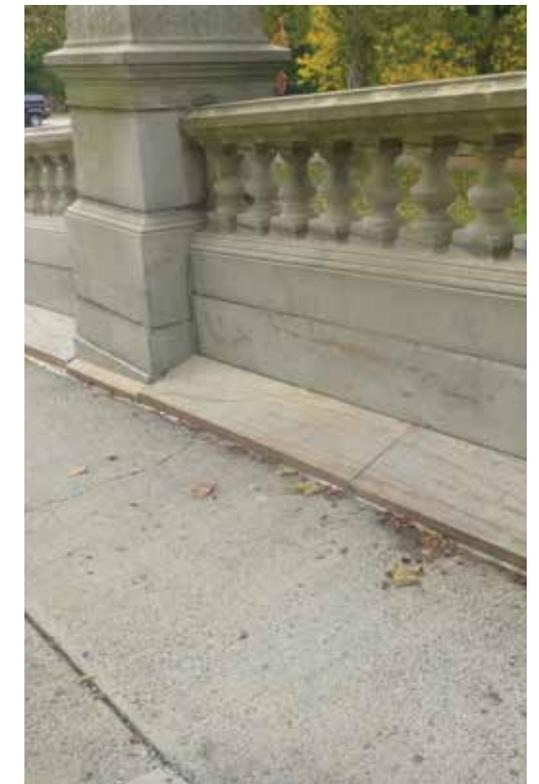
At the upper (approximately 12 feet tall) wall section, the retaining wall stones are horizontally displaced a few feet above the East Capitol Park grade (Figure 41a). We performed a structural analysis at this location, conservatively assuming saturated soil for the highest soil pressure. We assumed saturated soil because the deteriorated joints and damaged stone in the curb and balustrade above likely allow significant water entry into the soil below, which lacks a drainage system to manage this water. Our analysis indicates that under this conservative load, and not accounting for restraint due to the integration with the adjacent Eastern Approach walls, **soil pressure exceeds the retaining wall's calculated capacity and the depth of overloading correlates with the noted horizontal displacement.**

Curb stones are typically covered with linear rust stains, indicating scraping (and possible displacement) from plowing or snow removal (Figure 41c). Aggressively plowing against these unreinforced retaining walls and

Drive Surface The concrete drive surface is in poor condition with cracks, extensive patch areas, and regular surface wear. Surface deterioration is indicative of freeze-thaw damage, and is compounded by plowing and salting of the drive surface (Figure 41d). Given its poor condition and the partial removal required to complete the retaining wall work, we recommend replacing the entire drive surface.

Figure 41a Outwardly displaced retaining wall stones.

Figure 41b Cracked balustrade stones require repair.

Figure 41c Rust stained and displaced granite curbs along drive surface.

Figure 41d Drive surface is deteriorated with extensive patch areas.

At the ramp, we recommend disassembling and reconstructing the displaced or rotated portions of the retaining wall and the balustrade. The reconstructed wall will incorporate stainless steel pins to prevent movement between courses and damp proofing and soil drainage along the backside of the wall to both limit soil pressures and water deterioration of the wall. Similar to the Eastern Approach, the existing masonry will be repaired and cleaned (Figure 41b). Flashing will also be incorporated into the base of the balustrade to limit water entry. Reconstructing the retaining wall and related backside excavation requires partial removal of the driveway slab.

curbs increases the displacement. A snow melt system is recommended to limit maintenance and potential related deterioration.

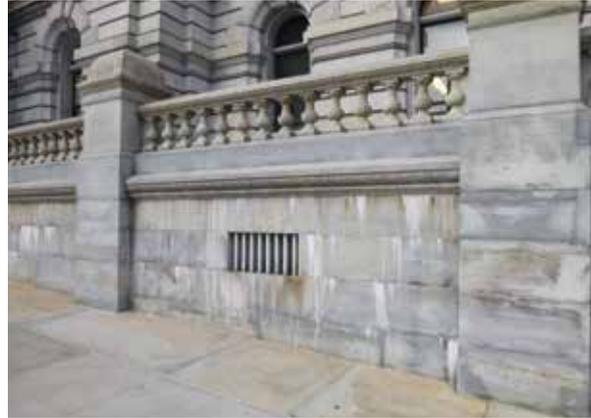
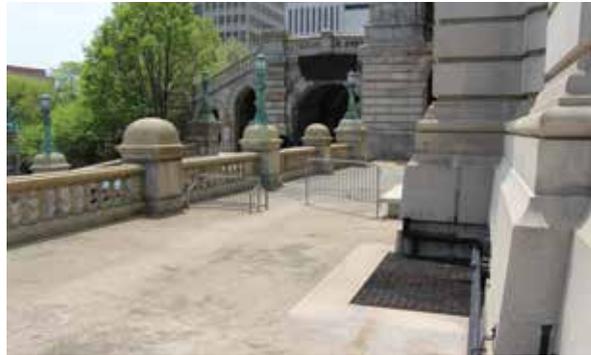
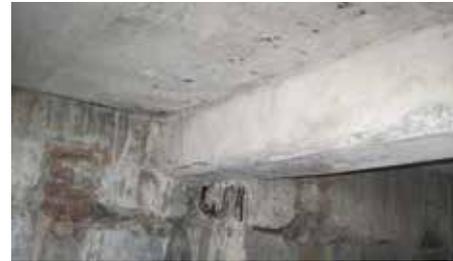
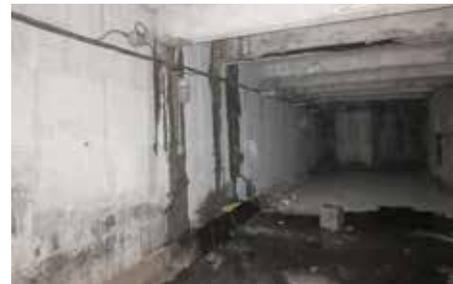
The Eastern Promenades are in serviceable condition with isolated damage to the concrete decks and walls, and granite cladding and balustrade (Figures 44a–d). Significant efflorescence and rust staining on the interior and exterior of the walls and on the underside of the deck slab indicate substantial water entry through deck deterioration (cracks, surface wear, and spalls at exposed form remnants cast into the deck); poor drain integration; deteriorated mortar joints; and failed sealants in the balustrade, control joints, and perimeter conditions (daylight is visible through control and perimeter joints). This water entry is causing the isolated damage due to freeze/thaw deterioration of the concrete and corrosion of embedded reinforcement and encased beams. Adding to the problem is the use of deicing salts, which can chemically modify the concrete and accelerate corrosion. The inadequate slope-to-drain of the concrete deck also allows water to pond on the concrete surface, accelerating deterioration.

Figure 44a Staining on promenade exterior walls.

Figure 44b Staining and deterioration below promenade decks.

Figure 44c Leakage observed at water testing location.

Figure 44d North promenade deck and barricades.

Both freeze-thaw damage and corrosion of embedded steel can be arrested by limiting water infiltration into the system. At the deck, this is most efficiently done by repairing the existing deck surface and providing a waterproof traffic coating over the promenade decks. A traffic coating will have a minor impact on the deck's appearance and will require periodic maintenance or reapplication, but a durable coating can provide decades of service at a fraction of the cost of reconstructing these decks. Because of the complex geometry at the balustrade, a more invasive approach is necessary to reliably stop water leakage through both the granite masonry and the perimeter transition joint. The installation of a flashing below the balustrade base provides a durable water management solution, which is consistent with similar flashing work performed elsewhere on the building. Flashing installation requires removal and reinstallation of the granite balustrade. Once water is controlled, the heavy staining that mars the perimeter walls can be cleaned and masonry joints pointed.

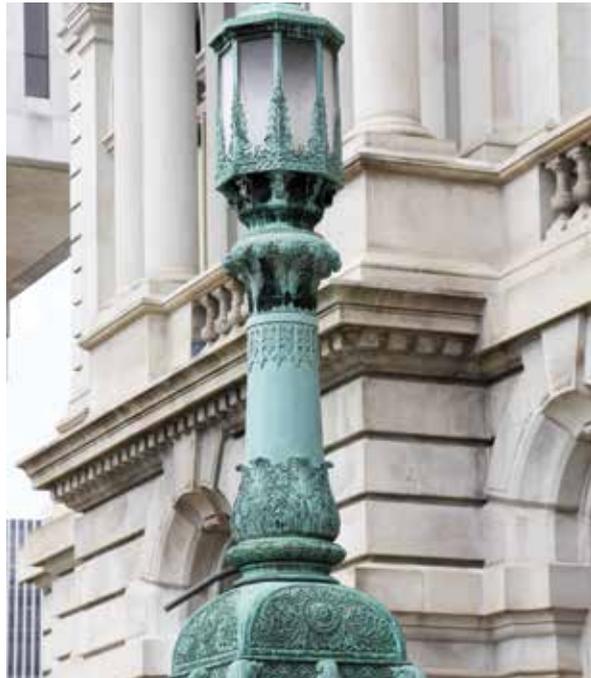
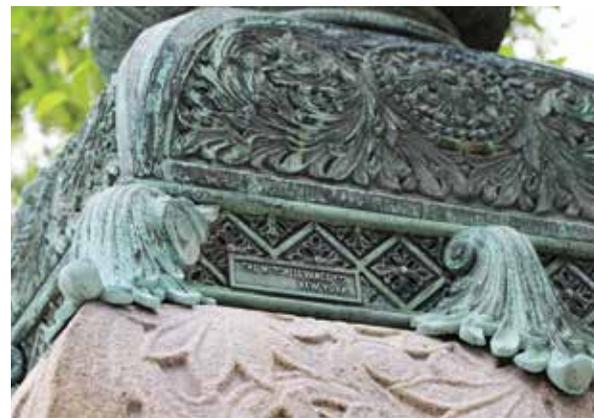
Exterior Lighting Historic decorative cast bronze light fixtures adorn the Eastern Approach, Eastern Promenades and Executive Ramp balustrades. The light fixture posts are original, though the lanterns were replaced in the 1930s, and the lamps are a contemporary system installed somewhat recently (Figures 46a–b). While the lanterns are not original, they match the lanterns used in the West Capitol Park. All exterior lighting is reported to work (Figure 46c), though we observed a few fixtures that did not illuminate; we assume these non-functional fixtures simply require lamp replacement. The bronze fixtures have a patina, being unsealed and exposed to the elements, and there is some runoff staining the granite below.

Six utilitarian flood lights are installed within the Eastern Approach vaults that span the Executive Ramp (Figure 46d). These fixtures are architecturally inappropriate and not original. The project includes rewiring and replacing with historically appropriate fixtures that will maintain the current level of illumination.

Figure 46a Typical cast bronze fixture.

Figure 46b Original cast bronze base.

Figure 46c Light fixtures in operation.

Figure 46d Contemporary flood light below Landing 4.
